Automated Analysis of Scaffold Joint Installation Status of UAV-Acquired Images

Abstract: In the construction industry, fatal accidents related to scaffolds frequently occur. To prevent such accidents, scaffolds should be carefully monitored for their safety status. However, manual observation of scaffolds is time-consuming and labor-intensive. This paper proposes a method that automatically analyzes the installation status of scaffold joints based on images acquired from a Unmanned Aerial Vehicle (UAV). Using a deep learning-based object detection algorithm (YOLOv5), scaffold joints and joint components are detected. Based on the detection result, a two-stage rule-based classifier is used to analyze the joint installation status. Experimental results show that joints can be classified as safe or unsafe with 98.2 % and 85.7 % F1-scores, respectively. These results indicate that the proposed method can effectively analyze the joint installation status in UAV-acquired scaffold images.

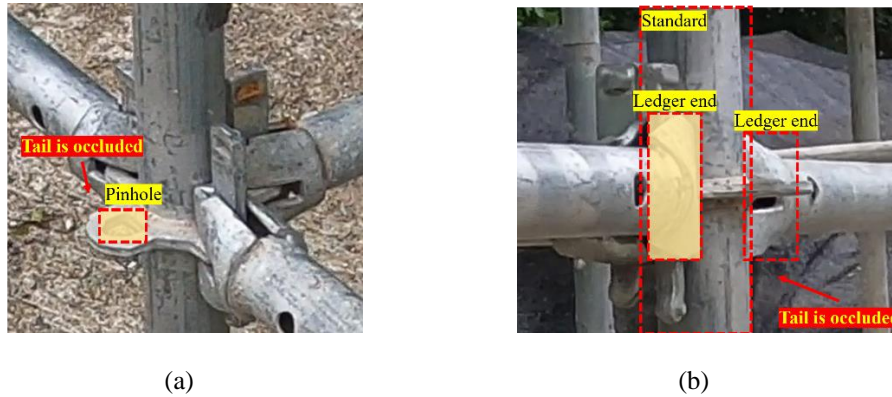
Figure 3. Examples of poor quality joint images; (a) vertically angled, (b) horizontally angled

It is not appropriate to use all joint images acquired by a UAV. The position and angle of the UAV may generate joint images of which quality is not fit for the safety analysis because the tail can be occluded by other objects. To use only desired image and analyze the installation status of the joint, a rule-based classifier is used. For example, if a pinhole is detected in the image (Figure 3(a)), the tail is likely to be occluded by the pinhole and the ledger end. If the bounding boxes of standard and ledger end overlaps with more than a certain ratio as shown in Figure 3(b), the tail

may be blocked by the standard. In contrast, if both tail and ledger end are detected, the joint is considered safe.

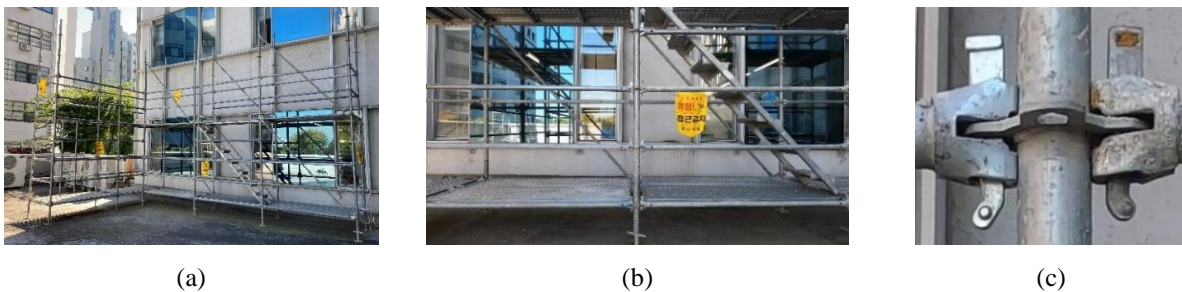
Figure 5. Site B; (a) the scaffold, (b) UAV-acquired image, (c) joint image

Two image datasets (Site A (Figure 4) and Site B (Figure 5)) were used in this research. 300 images from Site A and 60 images acquired from Site B were used for training and testing the joint detection model, respectively. Joint images were automatically cropped and used to train and test the component detection model. 693 joint images from Site A and 118 images from Site B were used to train and test the model, respectively. The data from Site A were used to determine the parameter values, while the data from Site B were used to test the rule-based classifier; a total of 1,716 joint images from Site B were used.
