## Non-Destructive Detection of Hertzian Contact Damage in Ceramics

**Abstract**—An ultrasonic technique using normal-incident compressional waves was used to evaluate the surface and subsurface damage in ceramics produced by Hertzian indentation. Damage was produced by a blunt indenter (tungsten carbide ball) in glass-ceramic, green glass and silicon nitride. The damage was classified into two types; (1) Hertzian cone crack, in green glass and fine grain silicon nitride, and (2) distributed subsurface micro fractures, without surface damage, produced in glass ceramic. The ultrasonic technique was successful in detecting cone cracks. The measurement results with the Hertzian cone cracks indicated that cracks perpendicular to the surface could be detected by the normal-incident compressional waves. Also shown is the capability of normal-incident compressional waves in detection distributed micro-sized cracks size of subsurface microfractures.

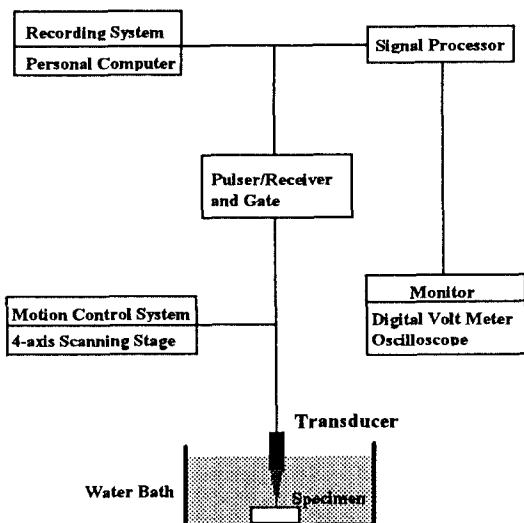
Fig. 5. Schematic diagram of the ultrasonic measurement system.

The ultrasonic system, schematically illustrated in Fig. 5, consists of a broadband pulser/receiver, a gate detector, an oscilloscope, a digital voltmeter, a personal computer, and a computer-controlled 4-axis scanning stage (X, Y, Z, and  $\phi$ ) for line and raster scan. The specimens were immersed in a water bath

coupling medium through which the pulsed wave travelled to and back from the specimen. The transducer was attached to a 4-axis scanning stage and used to transmit and receive ultrasonic signals in conjunction with a pulser/receiver unit. The measurements were carried out using a sharp-focused 50 MHz transducer with a spherical lens (focal length of 5.9 mm and fnumber of 0.8) to generate short wave pulses less than 0.1  $\mu$ s in duration. This transducer produced a measured half-amplitude beam width (known as the effective beam width) of 30 to 35  $\mu$ m in water at laboratory temperature. The actual operating frequency of this transducer was measured to be 35 MHz. At this operating frequency, the ultrasonic wave length in water is 43  $\mu$ m. The gated peak detector acquires peak amplitude values in voltage from the reflected ultrasonic signals when selected area of specimen is scanned. The peak amplitude data were then read and recorded by the personal computer through an analog to digital converter board. The step size of the raster scan was 5  $\mu$ m in both x and y direction.

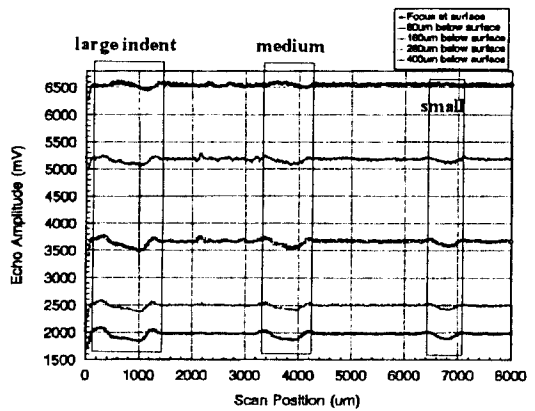
Fig. 9. (a) A schematic of three indents in glass-ceramic, and (b) line scans over the center of indents at various depths of focus.

Fig. 9(b) shows the line scans at various depths of focus,  $z$ , which are passing over the indent center, as shown in figure (a). When the transducer is focused at the surface, the topographical influence of the indent is again observed regardless of the size of the indent, as the decrease and increase in the echo-amplitude in the periphery of the indent and inside indent circle, respectively. The line scan results at various depths of defocusing, show conspicuous drop in the echo-amplitude at the region below the indent surface. It must be noted that when the defocusing depth increases the influence of damage zone on the intensity of reflected ultrasonic pulses increases as the ultrasonic waves travel more into and back from the damage zone.
