Journal of Korean Institute of surface Engineering
Vol. 29, No. 5, Oct., 1996

COMPARISON OF PLASMA-INDUCED SURFACE DAMAGES IN VARIOUS PLASMA SOURCES

Donghyen Yi, Jun-Sik Lee, Sang-Kyun Kim and Jae-Jeong Kim

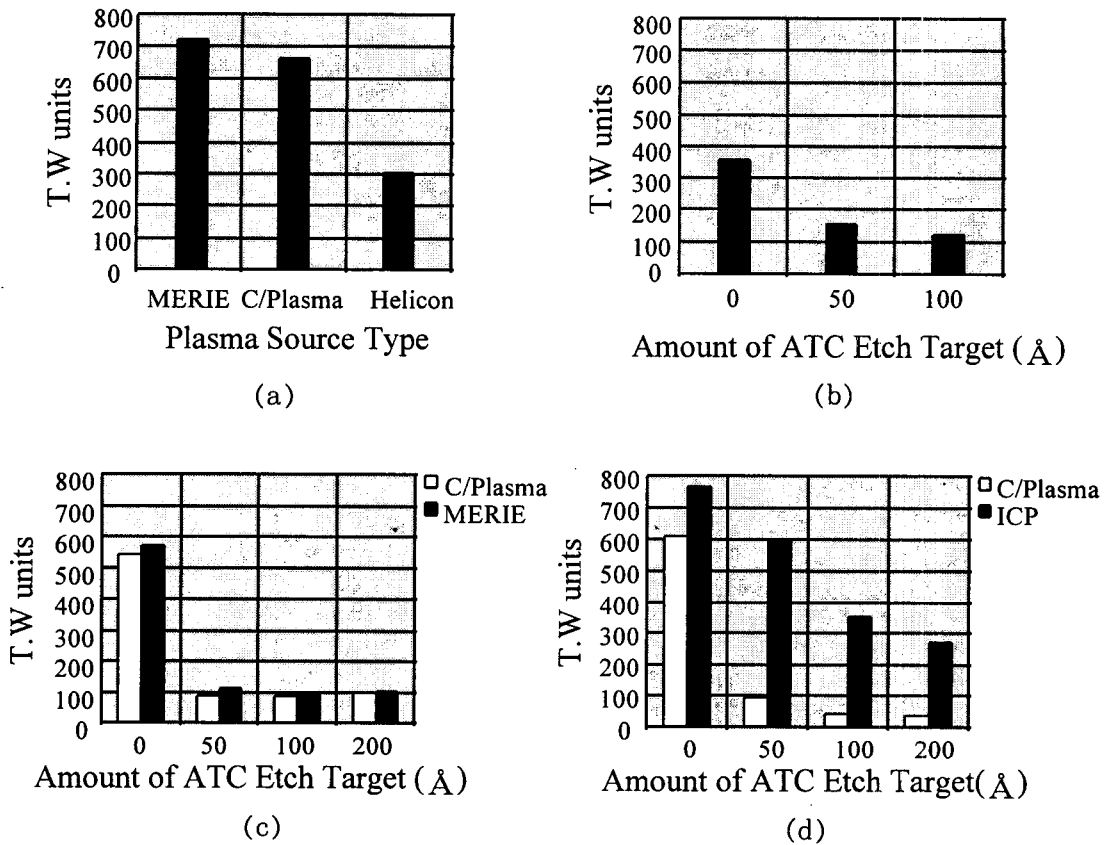
Therma wave measurements show the amorphous silicon state level through broken silicon bond by plasma damage. Some therma wave measurements result is shown in Fig. 1 for different etching processes and plasma type. Fig. 1(a) shows that helicon plasma

Fig. 1 Results of Thermo-Wave Measurements.

source had the smallest ion damage after LOCOS etching process. The other hand, MERIE and conventional plasma types have similar ion damage level. The thermo-wave measured values of MERIE type was decreased in half additional 500 Å silicon etch and some ATC (after treatment chamber) etch in Fig. 1(b). Fig. 1(c) shows the comparison of ion damage level of conventional plasma and MERIE type after LDD etching process. The damage status of those types were similar level, however, the damages were decreased after ATC etch. And the ion damage was not effected by the amount of ATC etch quantities. Fig. 1(d) shows the comparison of ion damage level of conven-

tional plasma and MERIE type after contact etching process. The damage level of the conventional plasma type was dramatically decreased after ATC etch. That type was not effected by the ATC etch quantities, but the ICP type has decreased the ion damage level by the ATC etch quantities. From this experiment, it is concluded that the ATC etching process can cure the ion damage due to plasma. Light etching treatment process make the broken dangling bond to be stable in the damaged silicon surface. That is why the light or ATC etching processes are used after plasma etching processes in manufacturing semiconductors.

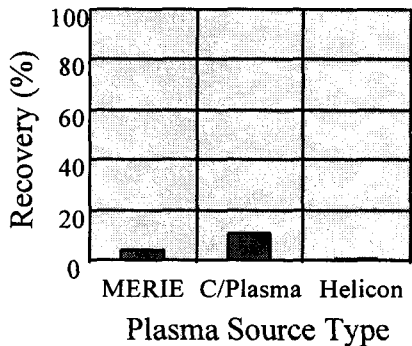
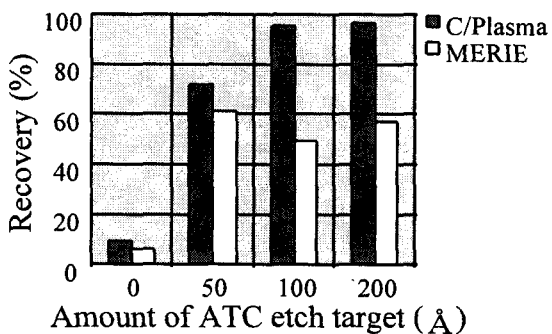
Life time measurements show the contaminants level after plasma etching processes and the measured values of them are presented by recovery percentages. The plasma contaminants status is low, if the recovery percentage is high after plasma etching processes. In Fig. 2(a), life time recovery was measured for MERIE, conventional plasma, and helicon source plasma types after LOCOS etching process. From this measurements, MERIE and conventional plasma types were recovered above 10%, but helicon source plasma was recovered only 1%. As result, helicon source plasma has more contaminants induced by plasma than MERIE or

Fig. 2 Results of Life-Time Measurements.

conventional plasma type. Fig. 2(b) shows life-time recovery results according to amount of ATC etch quantities after LOCOS and silicon etching processes in MERIE plasma type. Before ATC etch life time recovery was 15%, but after that treatment it was increased to 25%. For LDD etching process, however, the amount of ATC etch quantities devote a lot to life time recovery in MERIE and conventional plasma type as shown in Fig. 2(c). According to the amount of ATC etch quantities, life time recovery was increased for conventional plasma type, but no trend was shown for MERIE plasma type. In Fig. 2(d), recovery was 10 to 60% for conventional plasma type, however, recovery

was not effected by the amount of ATC etch quantities in ICP type after contact etching process. This means that surface polymerization could occur by high density plasma reaction or more contaminants could exist for ICP type etcher. From these measurements, it is concluded that the ATC etch could be helpful for the life-time recovery of some plasma damage processes.
