Determination of the Failure Paths of Leadframe/EMC Joints

Abstract

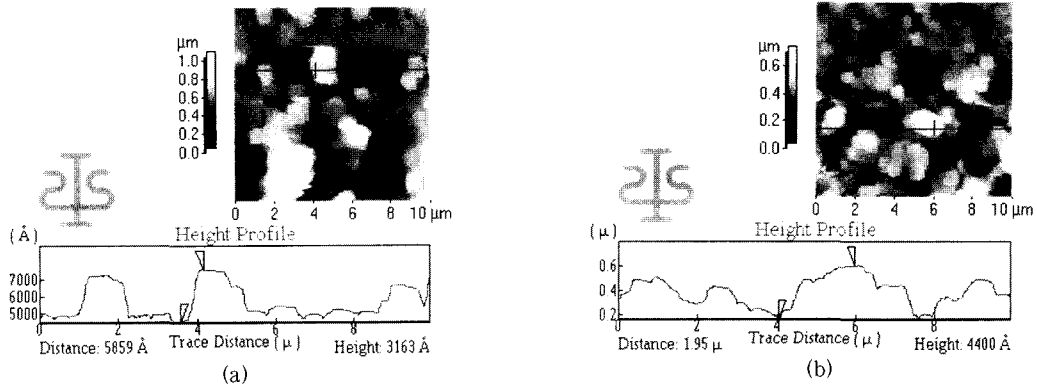
Fig. 5. AFM images and line profiles on the (a) leadframe side and (b) EMC side separated from four-minute oxidized leadframe.

AFM analyses on the fracture surface carried out to know the height difference between convex and concave region. $10\mu\text{m} \times 10\mu\text{m}$ area was scanned. Acquired images and line profiles are

shown in Fig. 5. According to the line profile results, the height differences in leadframe side and EMC side were 316.1 nm and 440 nm, respectively.

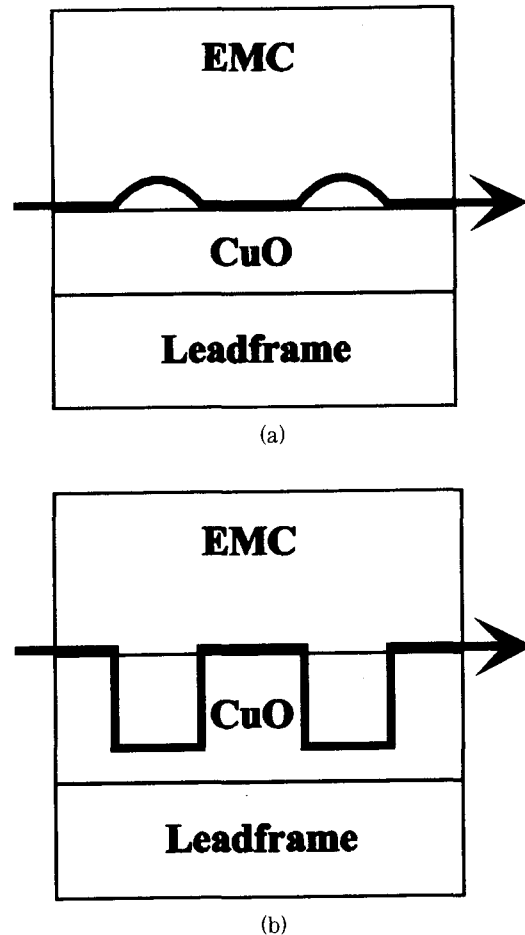
Fig. 7. Schematic illustrations of failure paths : (a) is for low oxidation time ($t < 2$ minutes) and (b) is for high oxidation time ($t \geq 2$ minutes)

Previous analyses on the fracture surface by using SEM, AES, EDS and AFM showed that failure occurred in a mixed mode for both A-type and B-type specimens. When the oxidation time is below two minutes (A-type specimens), failure occurred in a nearly interfacial mode near by the CuO/EMC interface in the non-debris region of the separated leadframe side and in a cohesive mode in the inside of EMC in the debris region. On the other side, when the oxidation time is more than two minutes (B-type specimens), nearly interfacial failure occurred in the vicinity of CuO/EMC interface, and cohesive failure in the inside of the CuO occurred in the convex region and concave region of the separated leadframe side, respectively. Schematic diagrams delineating the failure paths are shown in Fig. 7.

The reason why the nearly interfacial failure occurred may be ascribed to the real length of CuO needles. In case of the early stage of oxidation (A-type specimens), since the real length of CuO needles is short, the penetrating depth of epoxy resin into gaps among CuO needles must be short. Consequently, the mechanical interlocking between CuO needles and EMC is so weak that the fracture toughness of CuO/EMC interface is also weak. Hence most of failure occurs near by CuO/EMC interface with some exception. However, in case of the oxidation time is more than two minutes (B-type specimens), the entire
