Marine Transportation in the Philippines: The Maritime Accidents and their Causes

Abstract : *This paper details the maritime accidents that occurred in the Philippines from 1972 to 2010. Firstly, it describes the general maritime situation in the country. It was followed by the traffic and safety infrastructure and the prevailing weather in the archipelago. The third section deals with the accidents' statistics and their geographical locations which is further sub-divided into three regions. It is grouped according to 10-year period. This paper describes the actual maritime situations, the pertinent national regulations, the inter-agencies policies and their safety regimes. It illustrates the shipping environment in the country including the maritime aids and infrastructure and the on human element factors.*

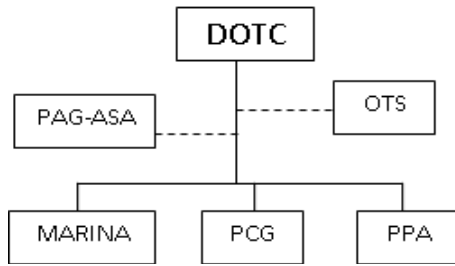
Fig. 1. Maritime related organizational structure

(DOTC) is the main government agency in-charge of the maritime transport. Its attached agencies are the Maritime Industry Authority (MARINA) which is mandated to integrate the development, promotion and regulation of the country's maritime industry^[6]; the Philippine Coast Guard (PCG) is responsible for the promotion of safety of life and property at sea, safeguard the marine environment and resources and enforce all applicable maritime laws; and the Philippine Ports Authority (PPA) whose responsibility as developer, operator, maintainer and regulator of all the ports under its jurisdiction.^[13] The Philippine Atmospheric, Geophysical & Astronomical Services Administration (PAGASA), while under a different government agency, gives information and advisory for the prevailing weather conditions and forecasts.^[7] The Office of Transport Security (OTS) is the single authority for all modes of transportation security in the Philippines per ICAO and IMO guidelines. OTS organized the Maritime Transportation Security Bureau (MTSB) to attend to the maritime concerns.^[1] Fig. 1 illustrates the hierarchical organization of maritime related agencies.

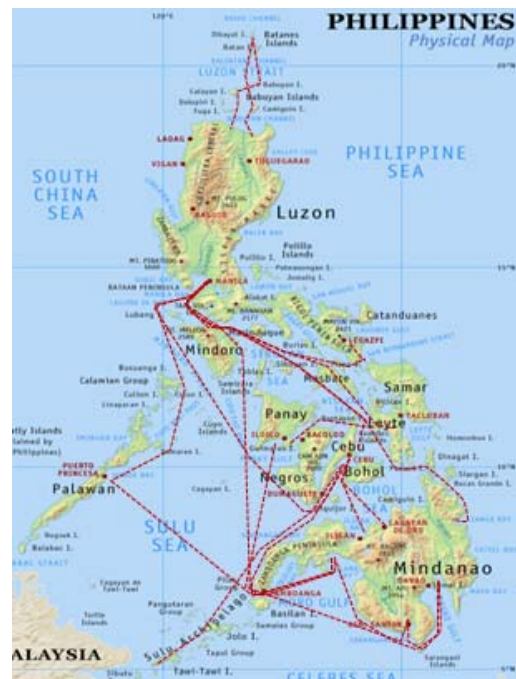
Fig. 2. Domestic shipping routes

Fig. 2 shows the traditional routes plied by domestic ships. The red dotted lines connect the main ports in the country with the other ports which are concentrated mostly between the small island-ports in the southern part of the country.

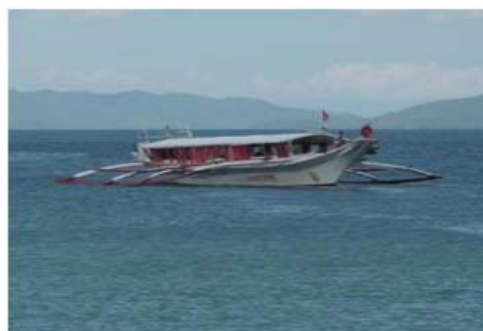
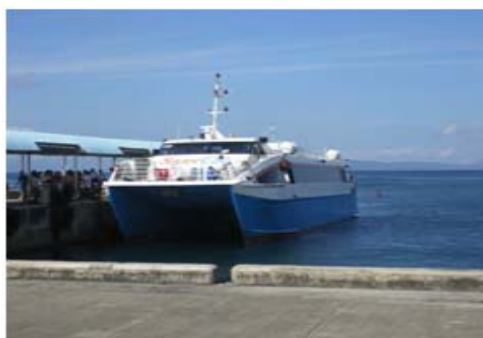
There had been a spate of major maritime incidents that occurred in the Philippines and claimed thousands of lives. Most of these sea disasters had been dubbed as the worst in maritime history in peacetime. The damages to the environment have been somewhat down-played due to the enormity of the lives lost and the porous setting of the islands dissipated the ecological damages caused by spilt or leaked oil and chemicals. Millions of Filipinos, many of them too poor to afford air travel, use the seas and waterways to travel between islands, on everything from fast steel-hulled ferries to wooden motorized dugouts with outriggers (Figs 4).

Fig. 4 Motorized banca with outriggers and Super-cat steel-hulled ferry

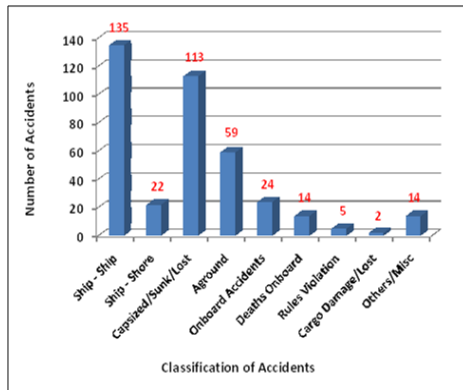
MUI list of casualties and online news and print articles. These data were gathered and compiled together and formed part of this paper. Fig. 5 shows the different types of accidents and these were grouped into different scenarios. This paper discusses only three types of accidents: Collisions, Capsized and Grounding.

Fig. 5 Types of accidents (1972 to 2010)

Other accidents reported as “Ship-shore” (22) involved ships in contact with shore facilities: bumping wharf, damage to wharf or fenders, damage to pier, damage to dolphin, hitting shore facilities struck the sea wall, ramming wharves, etc. “Onboard accidents” (24) involved those internal accidents like engine explosion, engine trouble, explosion, fire onboard; while “Deaths Onboard” (14) were those that fell overboard, one swiped by line overboard and those classified as plain death on board; “Rules Violations” (5) involved those reported misconduct and COLREGS violation; “Cargo Damage/Lost” only 2 of the reported jettisoned cargos and damage to cargos; and those accidents classified under “Others/Misc.” were: broke from tow, dragged/drifted, snapping anchor chain and other not identified and were only given their corresponding BMI coded numbers.

Capsized/Sunk/Lost (113) in Fig 5 are those that were reported as sinking, loss, capsizing, etc. in the official record of PCG and MARINA and is described here as “Capsized accidents” shown in Fig. 7. In the graph it can be readily observed that this accident has continuously decreased since 1972.

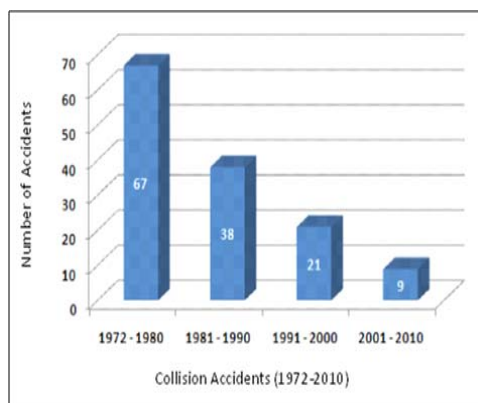
Fig. 6 Collision accidents (1972-2010)

“Ship-ship” accidents (135) were those accidents with contacts between ships. Official reports on these accidents classified them as: Collisions, allusions, ramming, bumping and hitting. These were all compiled under “Collisions accidents” shown by Fig. 6. The graph in Fig. 5 shows that of all reported accidents, the ‘Ship-Ship’ topped the scale which was attributed to poor navigation, non-observance of the rules of the road and lack of prudent seamanship.

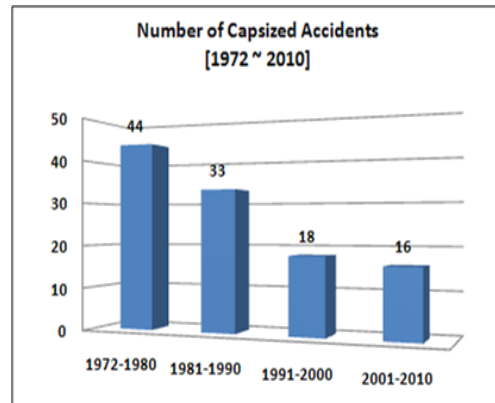
Fig. 7 Capsized accidents (1972-2010)

However, in terms of the number of fatalities, the accidents in the years 1980s until 2000s were the most horrendous. Data collected from various sources differ from the official recorded data of the number of casualties (dead and/or missing) because most of the ships lost and/or capsized were overloaded or passengers were poorly manifested.

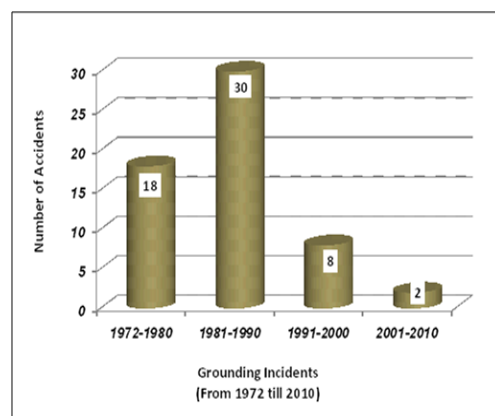
Fig. 8. Grounding accidents (1972-2010)

In Fig. 8 graphs the “Grounding” accidents (59) and were classified, in the official record, as ‘grounding’, ‘hit a rock’, ‘hitting submerged object’, ‘submerged’ and there is one reported as ‘intentional beaching’.

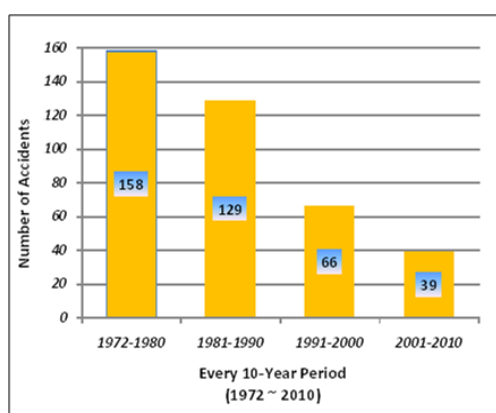
Fig. 9 Accidents grouped in 10-Year period (1972 – 2010)

The list of accidents was grouped according to ten-year periods as shown above by Fig 9. It can be observed that the numbers were declining, through the years, however, it cannot be safely assumed that progress has been attained in minimizing their occurrence.

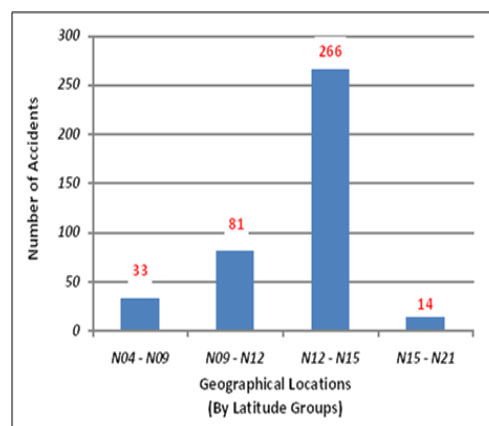
The maritime accident’s geographical locations were grouped by latitudes as shown in Fig. 10. This covers the whole archipelago from the northernmost territories of Amianan islands (21°45’N, 121°56’E) down to Tawi-tawi islands (04°48’N, 119°50’E) in the southern tip of the

Fig. 10 Accidents grouped by latitudes

Philippine archipelago. Fig. 10, also, shows that the latitudes N12–N15 degrees, where the NCR and the Southern Tagalog region are located, have the most occurrence of accidents.

Fig. 12 highlights the crowded red dots in the area of Manila Bay and the southern port of Batangas Bay and adjacent seas where the approximate locations of most of the major accidents (266, Fig 10) occurred. The approximate geographical locations of these accidents were sourced from PPA, Marina, PCG and various news clippings, located through the British Admiralty (BA) charts covering the area of accident and then plotted onto the electronic charts covering the areas concerned.

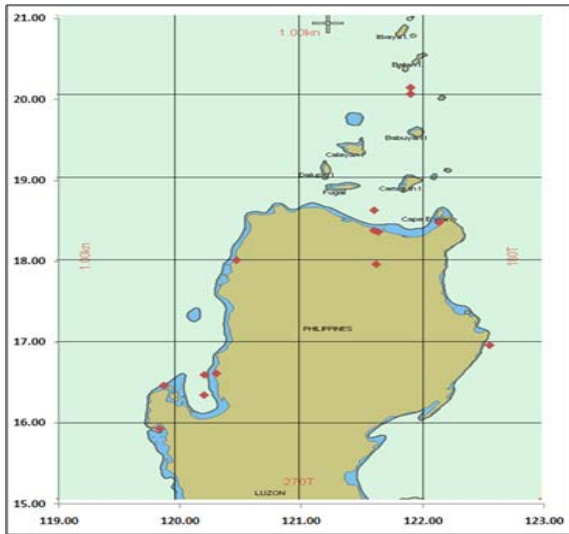
The figures below, meanwhile, show the general locations of the maritime accidents superimposed on ARC’s charts and were plotted as red dots. Fig. 11 shows the accidents along the coast of Lingayen Gulf, Cagayan River

and the Babuyan Island in the northern parts of the country.

Fig. 11 Central and Northern Luzon area

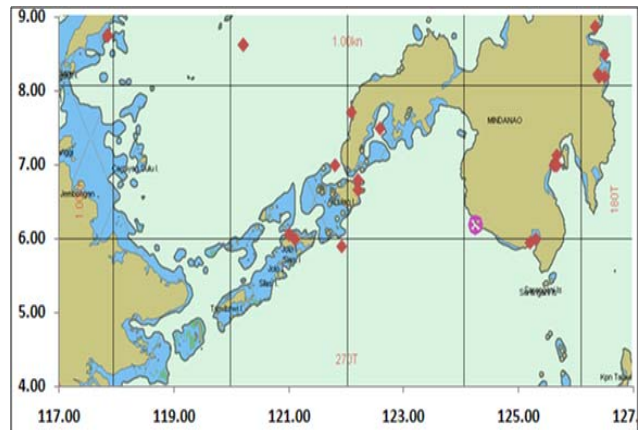
Fig. 13 plots the 33 accidents that occurred in the southern parts of the country covering the Mindanao archipelago

and the Jolo group of islands.

Fig. 13 Mindanao and Sulu Islands region
