Detection and Comparison of Surface Defects in Pipe Welds

Key Words : Carbon Steel Pipe(탄소강관), Weld Zone(용접부), FEM(유한요소법), IRT(적외선 열화상)

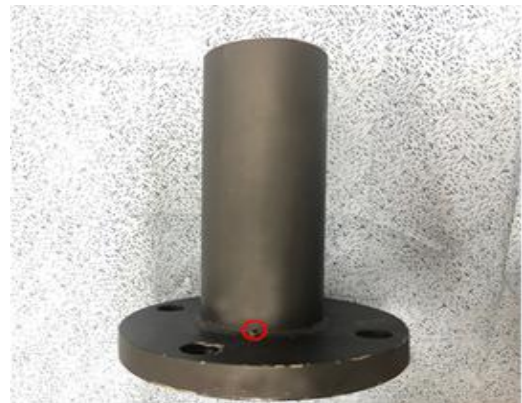
Fig. 1 Carbon steel pipe flange specimen

straight pipe and flange to a 65mm diameter with a 3mm thickness. After welding, artificial defects were added by drilling and marked with a red circle. Since infrared thermography significantly affects the rate of radiation, black matte paint was applied to the test piece to reduce this rate. Fig. 1 represents a test piece bonded by welding the carbon steel straight pipe and flange.

Infrared thermography was performed using a halogen lamp heat source with a 1 kw output on the welds of carbon steel pipes. Halogen lamps were used to irradiate the welded sections of the carbon steel pipe test piece in Fig. 1 for 35 seconds. As a result, it was confirmed that the artificial defect spot2, which had a relatively higher temperature than the surrounding area, featured a hotspot. The normal, non-defective parts of spot1 and spot3 had lower average temperatures than the defect areas; however, during the ongoing light survey of the halogen lamps, the temperature steadily increased. Hotspots on the welded sections enabled the identification of faulty locations as well as the presence of defects. Fig. 2 shows a thermographic image of the carbon steel pipe flange measuring the halogen lamps as a

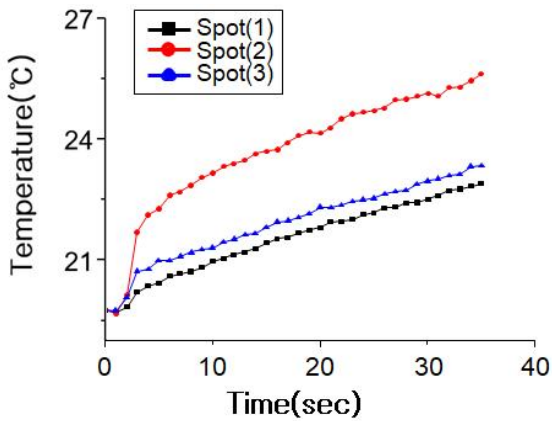
Fig. 3 Carbon steel pipe thermal image data

heat source. Fig. 3 features the data from Fig. 2, which was obtained during infrared thermographic imaging and reveals the temperature variation over time in this spot.

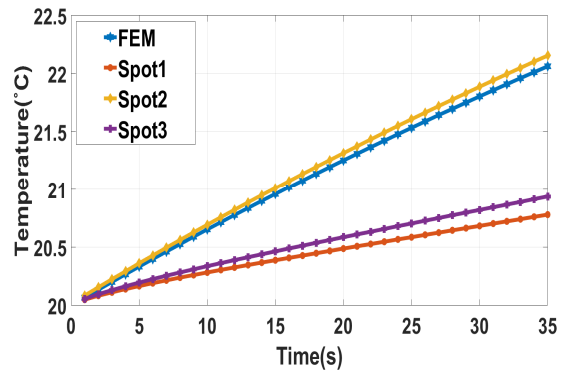
Fig. 6 Comparison of infrared thermal imaging experiment and FEM analysis

Fig. 6 presents a graph comparing the experimental value of the thermographic image of the carbon steel pipe flange welds with the finite element analysis. FEM represents the finite element analysis values while spot1, spot2, and spot3 represent the experimental thermographic imaging values. Observing the graph in Fig. 6, it is clear that the FEM values and spot2 where a hotspot occurred had a temperature of about 22°C, while spot1 and spot2 without any defects had a temperature of about 21°C.
