Research Paper

## 공동주택 하자접수 유형변화 및 특징에 관한 연구

# A Study on the Changes in Types and Characteristics of Defects in Apartment House

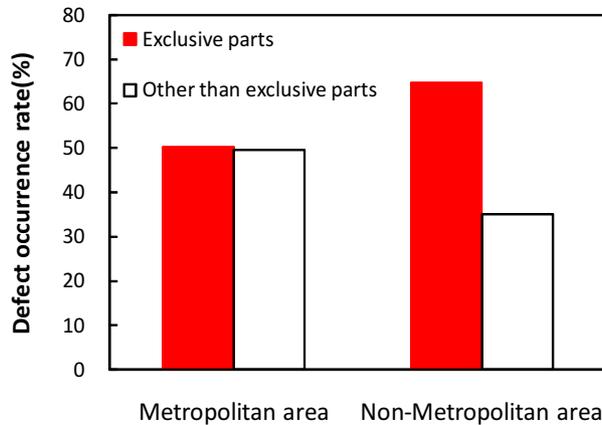
**Figure 2.** Defect acceptance rate by region

Table 3, 4에 나타난 공사종류별 접수현황을 분석하면 기계설비를 제외한 상위포지션 공정 대부분 전용 부분에서 발생하는 하자들이다. 공사종류별 접수현황 항목들 중 석공사, 도장공사는 전용 부분 보다 공용부분에서 더 많이 발생할 수 있는 하자들이다. 석공사의 경우, 외벽, 내/외부 공용부 바닥에 주로 시공되고 전용 부분에서는 일부 인테리어 마감으로 사용될 뿐 그 이상 적용된 사례는 드물게 나타난다. 도장공사의 경우도 외벽 도장 및 복도, 홀, 지하주차장 벽, 천장 등에 대부분 사용된다. 전용 부분에는 최근 발코니 확장으로 인해 도장공정 자체가 점차 줄어들고 있다. Figure 2는 지역별 하자접수 비율(전용 부분, 비 전용 비분)을 나타낸 것이다.

전용부분과 그 이외 하자접수 비율을 비교해보면, 수도권에서 전용 부분(실내 마감, 창호, 가구 등)에 주로 발생하는 하자 와 그 이외 하자발생 비율이 최소 50.4 : 49.6(최대 59.5 : 40.5) 대략 5 : 5 비율을 나타내고 있으며 2010년 이전과 현재의 차 이 또한 거의 없는 것으로 나타났다. 비수도권의 경우 전용부분과 그 이외의 하자접수 비율이 최소 64.9 : 35.1(최대 74 : 26)

대략 7 : 3 비율을 나타내고 있다. 수도권에서는 전용부분과 그 이외 하자 발생이 유사한 비율을 보이고 있지만, 비수도권에서는 전용 부분 하자접수가 그 이외 하자접수보다 조금 더 높은 것으로 나타났다. 이러한 원인은 과거와 달리 주거를 거주 목적보다 자산의 개념으로 여겨지는 사회적 인식 때문으로 집값이 상대적으로 높은 수도권에서 더욱 뚜렷이 나타나고 있다. 또한 공용부분 하자로 인한 대외 이미지 손상 및 그로 인한 자산 가치가 하락하는 것을 방지하기 위해 전용부분 이외에 대한 관심이 과거보다 높아지고 있기 때문으로 판단된다.
