Identifying Environmental Factors near Construction Sites Affecting Pedestrian Safety

Abstract: Construction projects in urban areas often disrupt pedestrian paths and expose pedestrians to risks by forcing them to detour onto roadways. Despite rising pedestrian fatalities and injuries near construction sites, most research predominantly focuses on the safety of on-site workers, with limited studies addressing pedestrian safety. This study aims to fill this gap by identifying environmental factors that cause discomfort to pedestrians, potentially leading to hazardous impacts. A total of 252 photos of streetscape areas near construction sites, including seven environmental factors (i.e., traffic cones, fences, barrier walls, materials, heavy equipment, roads, and sidewalks), were collected and evaluated by 41 participants using a 5-point Likert scale. The survey findings indicate that barrier walls enhance pedestrians' perception of safety. Conversely, it is observed that traffic cones, materials, and heavy equipment have adverse effects on pedestrian safety. These results underscore the need for enhanced safety measures targeting these high-risk factors to create pedestrian-friend

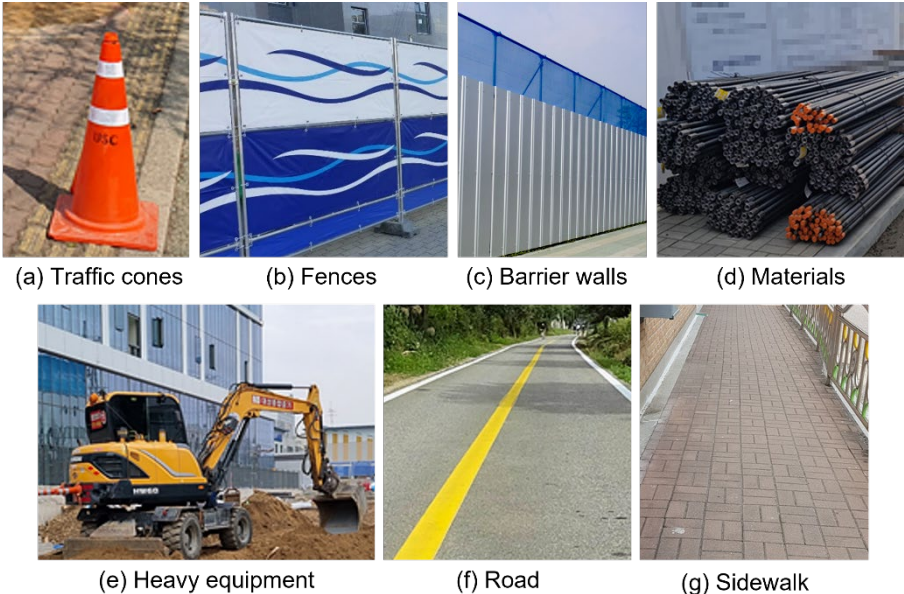
Figure 1. Environmental factors pertaining to pedestrian safety

Through a comprehensive literature review and field observations, this study identified seven types of environmental factors that may influence pedestrian traffic near construction sites. The first three objects are temporary measures used to separate pedestrians from construction work zones. These measures encompass traffic cones, fences, and barrier walls, as depicted in Fig. 1 (a) to (c). Previous research indicates that many construction sites often lack adequate temporary measures for pedestrian safety [13]. Furthermore, while these measures are intended to enhance pedestrian safety, improper placement can introduce hazards and lead to confusion among pedestrians [13]. The fourth environmental object is construction material (as depicted in Fig. 1 (d)). Various materials including piles of rebar, stacks of bricks, bags of cement, and construction debris all fall into this classification. In general, construction materials are perceived as encroaching on pedestrian space, reducing the usable width of sidewalks. It has been found that sidewalk encroachment is consequently linked to fatal pedestrian crashes [14]. The fifth environmental object is heavy equipment (as depicted in Fig. 1 (e)). Heavy equipment always requires careful attention to protect pedestrians, and therefore, flaggers should be in place to manage traffic [7]. The last two objects are roads and sidewalks, as depicted in Fig. 1 (f) and (g). From statistics regarding pedestrian fatalities, it is evident that high-volume and high-speed traffic on the roads can significantly increase the likelihood of crashes [8,15]. Conversely, the presence of sidewalks, particularly straight, wide, and well-paved sidewalks, could mitigate the likelihood of pedestrian accidents [5,12].

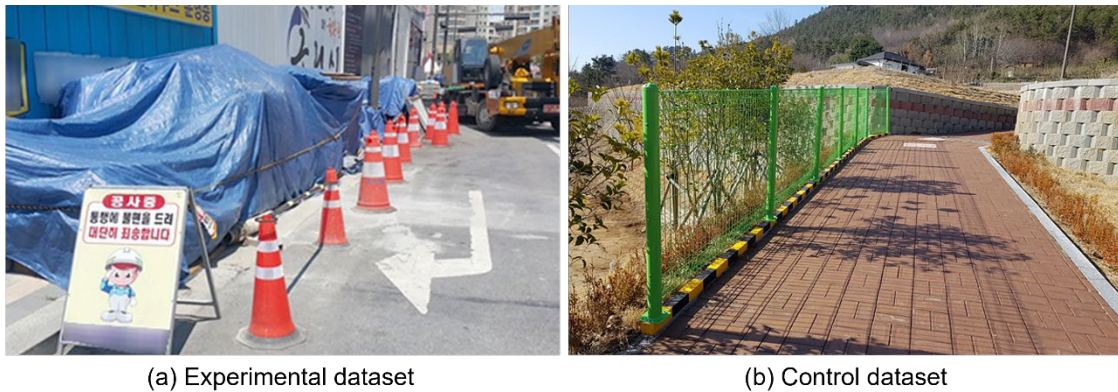
Figure 2. Representative photos from the experimental and control dataset

This study collected photos of streetscape areas near construction sites by utilizing a web scraping tool to extract images from Google Images (<https://www.pullywood.com/ImageAssistant/>). The collected photos underwent manual screening, and any photo that did not include at least one of the seven specified environmental factors was removed from the dataset. Photos with resolutions below 320*320 or above 1920*1080 were also excluded from the dataset. To supplement the dataset, artificial intelligence-generated images were created using text-to-image models (<https://www.bing.com/images/create>). Consequently, a total of 216 photos were collected for the experimental dataset, and an additional 36 photos containing only sidewalks were collected to serve as a control dataset. The number of environmental factors found in a single photo ranges from 1 to 6. As an example, the representative photo from the experimental dataset, shown in Fig. 2 (a), encompasses six environmental factors: traffic cones, barrier walls, construction materials, heavy equipment, roads, and sidewalks. In contrast, the representative photo from the control dataset, illustrated in Fig. 2 (b), solely features sidewalks. Among the seven types of environmental factors, excluding roads and sidewalks, barrier walls are the most frequently observed in the experimental dataset, appearing in 98 out of 216 photos. Table 1 provides an overview of the frequency of occurrence of environmental factors across the two datasets.

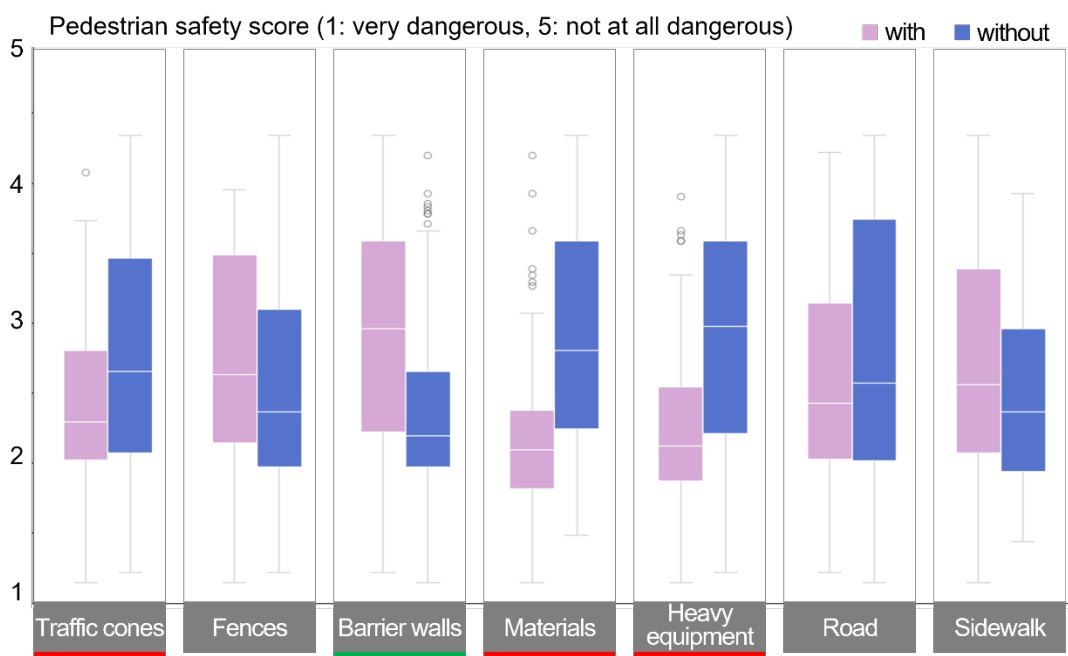
Figure 3. Boxplot of environmental impacts on pedestrian safety

Conversely, for factors with negative values in the mean difference, such as traffic cones, materials, and heavy equipment, significantly lower pedestrian safety scores were observed when these objects were present compared to when they were absent, as indicated in Table 3. This is because traffic cones often indicate ongoing construction activity or hazards, causing pedestrians to perceive higher risks. Similarly, the presence of construction materials and heavy equipment can create obstacles and reduce the available space for pedestrians, leading to a heightened sense of danger to pedestrians. On one hand, the presence of fences and sidewalks slightly raised pedestrian safety scores, while the presence of roads slightly lowered them. However, there was no statistically significant difference in the mean pedestrian scores between conditions for factors like fences, roads, and sidewalks. Fig. 3 presents a box plot that graphically demonstrates the impact of different environmental factors on perceived pedestrian safety. Factors that significantly improve pedestrian safety, such as barrier walls, are highlighted in green. In contrast, elements that have a statistically significant negative effect - such as traffic cones, materials, and heavy equipment - are marked in red.
