敬天寺 10層石塔 復原

- 相輪部 -

Study for the restoration of Gyeongcheonsa Pagoda

- top of pagoda -

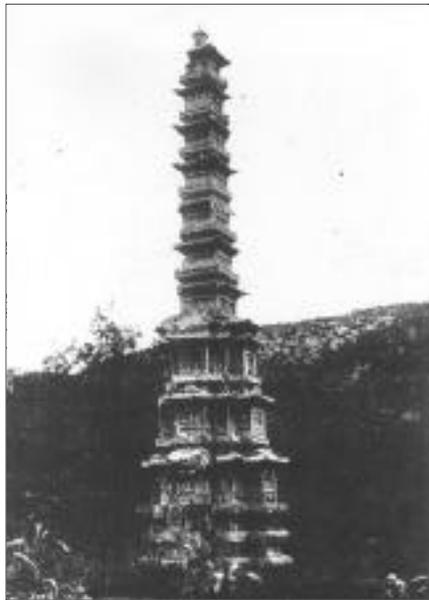
<圖 1> 10 (1902)

10 ()
 1907 , 1918
 가 1960
 가 ,
 , 1995 2002
 , 1902 1960
 가
 1902 (圖 1) 10 가 가
 , 1960 家形 相輪 10
 가 (圖 2). 10
 가

(圖 1)

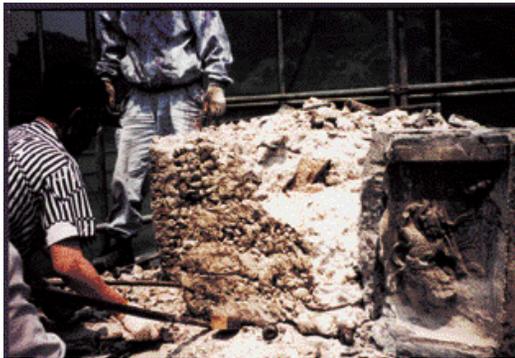
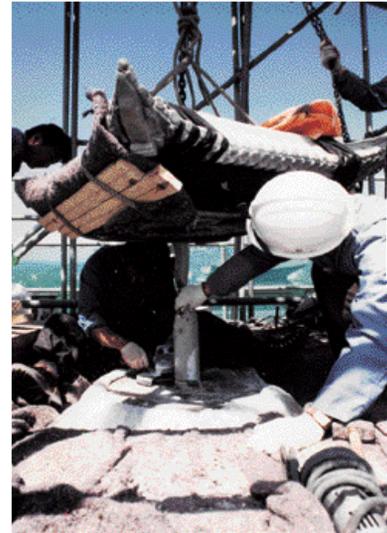
<圖 3 - 1> 1995

<圖 3 - 2> 1995

(圖 3 - 1 · 2).

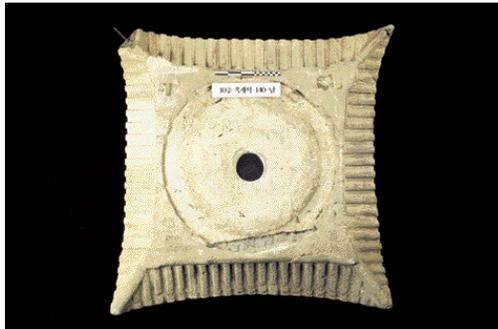
10 (圖8 - 1) ()
)
 . 10
 ,
 . 88mm,
 693mm, 가 10mm .
 (693mm) (668mm)
 (圖8 - 2) ²⁵⁾(圖8 - 3)
 가 .

<圖 8 - 1> 10

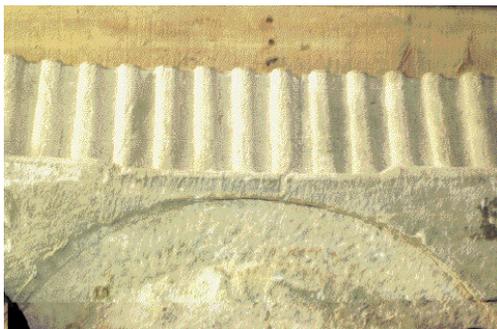
<圖 8 - 2> 10

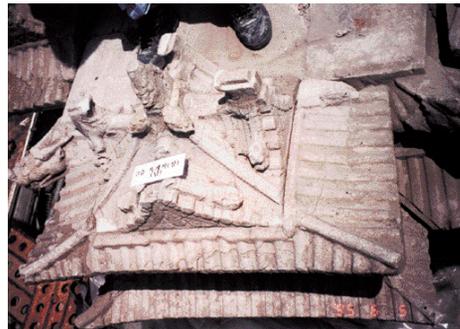
<圖 8 - 3> 3

25) 1 , 2 , 3 ()
 가 .

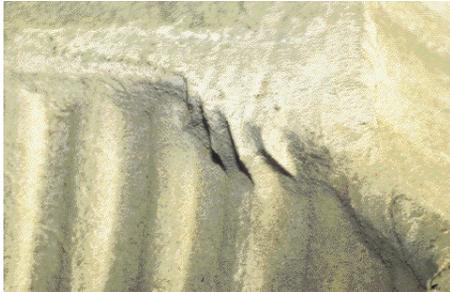
<圖8 - 4> 10

(圖 8 - 4)

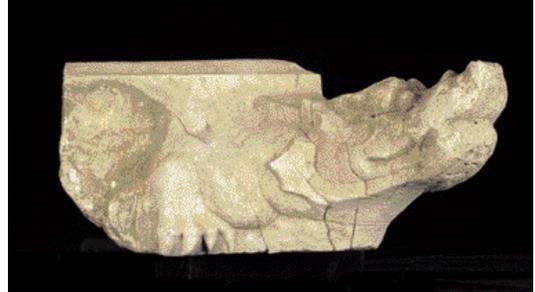
<圖 8 - 5> 3

26) (圖 8 - 5) .

(圖 8 - 5)

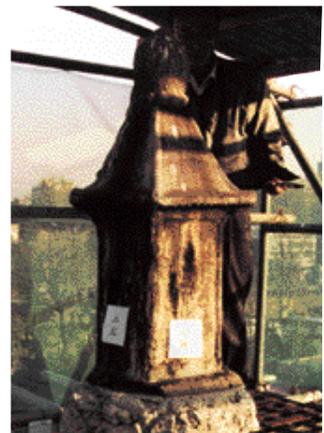
<圖 9 - 1>
가

(圖 9 - 1)

12mm

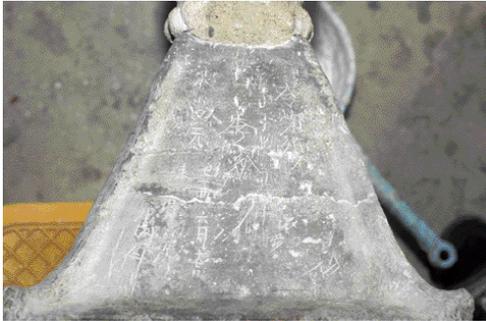
<圖 9 - 2> 가

“李業 /辛

丑 /李.../ 尙元 六月十七日/高 / /
...../ 川.....”

(圖 9 - 2)

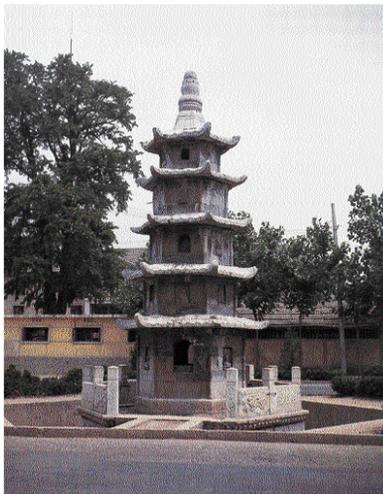
江蘇城 楊洲 木蘭院石塔²⁹⁾(圖10) 唐 840 , 清代

<圖10> 江蘇城 楊洲 木三元石塔

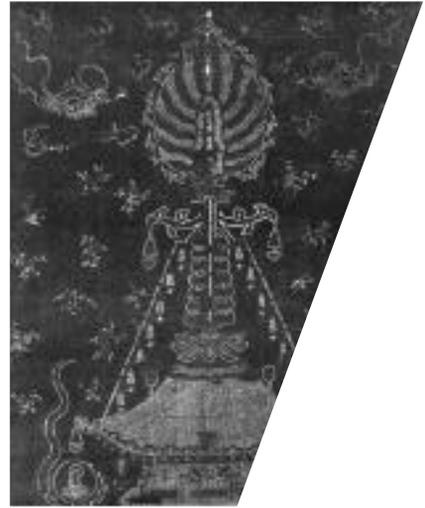
京都 東寺 金銀字法華經寶塔圖(1369)³¹⁾ (圖 12)

<圖12> 金銀字法華經寶塔圖
