Characteristics of a Corona between a Wiring Clamp (Dead End Clamp) and a Porcelain Insulator Used in a 154kV Power Receptacle

Abstract : The occurrence of a corona is that electrical discharge due to the heterogeneity that occurs when an electrical field is concentrated in an electrode due to a cusp formed on said electrode. Wire treatment at the end of a 154kV dead end clamp for end users accelerates the occurrence of corona, which in turn leads to power loss and noise. In this study, the characteristics of the corona which occurs between porcelain insulators and support clamps of overhead lines used in 154kV power receiving facilities for end users were investigated. The corona, which cannot be identified by one common method, was measured utilizing a UV image camera. A risk assessment for fire damage and its status was suggested. The stress distribution of the electrical field by length of bare wire was suggested by means of the finite element method (FEMLAB). As a result, it was found to affect a porcelain insulators. These results can be utilized for the enhancement of clamp installation and safety in power facilities.

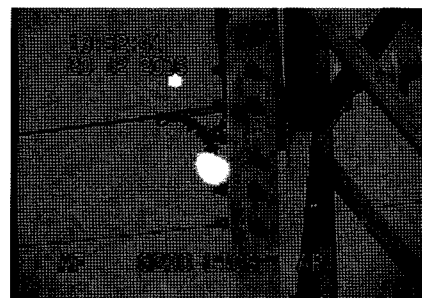
Fig. 3. Photographs of corona occurrence in the reserve wiring of 154kV power receiving facilities

Fig. 3 shows the image of corona occurring at the end of a bare wire with a dead end clamp on a reserve line at the site of a 154kV power facility. The use of a

(a) End Line Part

(b) Insulator Corona Part

dead end clamp as shown in the figure is a style used mainly in the 1970s; it is no longer used in new facilities. As this type of clamp was currently installed at the site, there is an element of risk for the site.

The area where the corona occurred began from the point where the end electric field of wire is concentrated. Where there is surface contamination of some of the support insulators, it can be seen that the corona is concentrated toward the insulators from the end of the wire. In the facility using a dead end clamp as shown in Fig. 3, there was a difference in the strength of corona occurrence; this occurred in all of the power facilities. It was found that the strength of corona occurrence becomes greater as deterioration factors such as humidity and dust increase.
