Influence of surface modification techniques on shear bond strength between different zirconia cores and veneering ceramics

PURPOSE. Veneering porcelain might be delaminated from underlying zirconia-based ceramics. The aim of this study was the evaluation of the effect of different surface treatments and type of zirconia (white or colored) on shear bond strength (SBS) of zirconia core and its veneering porcelain. **MATERIALS AND METHODS.** Eighty zirconia disks (40 white and 40 colored; 10 mm in diameter and 4 mm thick) were treated with three different mechanical surface conditioning methods (Sandblasting with 110 μm Al_2O_3 particle, grinding, sandblasting and liner application). One group had received no treatment. These disks were veneered with 3 mm thick and 5 mm diameter Cercon Ceram Kiss porcelain and SBS test was conducted (cross-head speed = 1 mm/min). Two and one way ANOVA, Tukey's HSD Post hoc, and T- test were selected to analyzed the data ($\alpha=0.05$). **RESULTS.** In this study, the factor of different types of zirconia ceramics ($P=.462$) had no significant effect on SBS, but the factors of different surface modification techniques ($P=.005$) and interaction effe

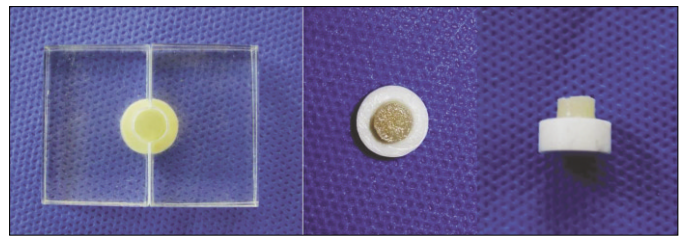
Fig. 1. Adjustable Plexiglas mold for condensing the veneering ceramic and prepared specimens for SBS test.

The prepared zirconia discs were placed in an adjustable Plexiglas mold (Fig. 1) where a space with 5 mm diameter and 3 mm height was available above the core material for condensing the veneering ceramic. The veneering ceramic powder (Cercon Ceram Kiss dentin, DeguDent) was mixed with an appropriate amount of the respective liquid according to the manufacturer's instructions and the obtained slurry was plotted with absorbent paper to draw excess water. The mold was filled and ultrasonically condensed. Layered zirconia discs were fired according to the firing program of the manufacturer (Table 2) in a firing furnace (Programat P300, Ivoclar Vivadent AG, Schaan, Liechtenstein). To compensate for the porcelain shrinkage during the sintering process, two separate firings with the same conditions were required to establish the correct diameter and thickness (Fig. 1).

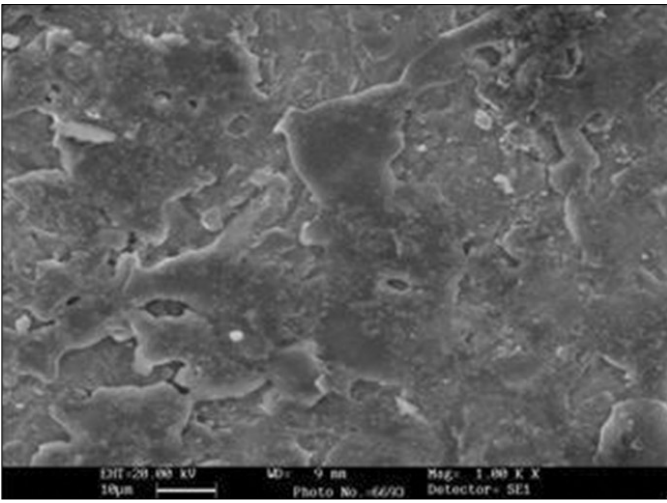
Fig. 2. SEM micrographs of liner application subgroup in colored zirconia group after shear bond strength testing (original magnification $\times 1000$).

white zirconia group but increased it in colored zirconia group (Fig. 2). However, these values were not significantly different from “as milled” groups in both types of zirconia. This was similar to results achieved by Aboushelib *et al.*²⁹ So it can be concluded that in the case of white zirconia cores, liner application decreases bond strength between core and veneering ceramic and increases the percentage of interfacial failure. Kim *et al.*⁶ stated that the liner application significantly decreases the shear bond strength compared to airborne-particle abrasion. Tinschert *et al.*⁴⁰ stated that, the liner application can significantly weaken the bond strength and increase the percentage of interfacial failure between zirconia core and pressable veneer ceramics.

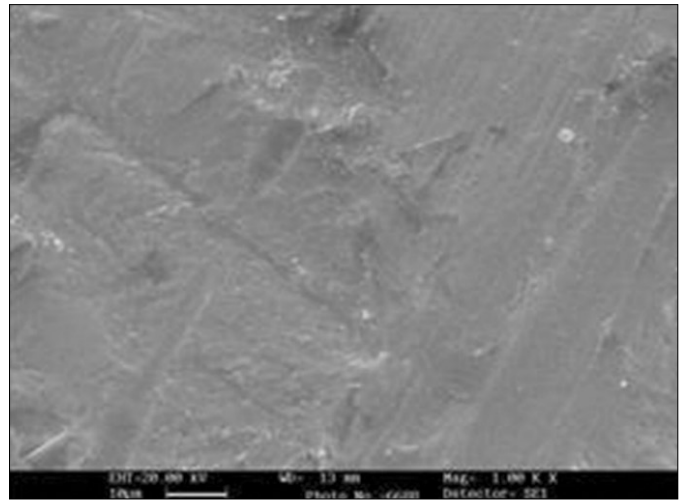
Fig. 3. SEM micrographs of ground subgroup in white zirconia group after shear bond strength testing (original magnification $\times 1000$).

In contrast to the assumption that a rougher surface provides higher bond strength due to a larger surface area for bonding²⁴ the results of the present study showed that surface grinding have a counteracting effect on the shear bond strength, especially in white zirconia group (significant lower SBS value than “as milled” ($P=.001$) and liner ($P=.05$) groups). It has been said that grinding can develop high stresses and form severe surface cracks which can lower the strength and reliability of the material.³¹ The ground surface is characterized by deformed and displaced material at the edge of the scratches, large defects unevenly distributed and micro-cracks (Fig. 3). It is stated that hand grinding is more effective than lapper-machine grinding, and air-borne particle abrasion is more effective than grinding in inducing the T \rightarrow M transformation.⁵ But some authors stated that the locally developed temperature in grinding may have exceeded this transformation temperature.³¹ Kosmac *et al.*³¹ stated that air-borne particle abrasion can produces the highest amount of the monoclinic phase and the lowest amount of the monoclinic phase can be obtained after grinding procedure. They concluded that air-borne particle abrasion may be considered as a powerful clinical technique for strengthening Y-TZP. In contrast, grinding may decrease the strength and reliability of prefabricated zirconia elements. According to Kim *et al.* observations,⁶ air-borne particle abrasion increases surface roughness and contact surface
