Investigation on electrochemical performance of Al anode material for marine growth prevention system

Abstract: Aluminum anode of marine growth prevention system for ship is installed in seachest or sea water strainer. The Al anode is connected to a control panel that feeds a current to the anode. The dissolved ions produced by the anode are transferred in sea water, spreads through the sea water pipe system and creates a protective film in the pipelines. Thereby, corrosion in pipeline system significantly is reduced. In application on condition as a steel ship, the big accident can be caused by the corrosion. Accordingly, in this research, we evaluated influence of applied current and flow velocity on electrochemical characteristics of Al anode for marine growth prevention system (MGPS). Based on the results of the erosion-cavitation experiments, cavitation rate increased greatly until 120 min. of the experimental time and decreased a little at the point of 180 min. where pit grew and merging occurred but showed a tendency of steadily increasing consumption rates. Based on the results of the Tafel analysis, compared to static states, corrosion current densities show a rapidly inc

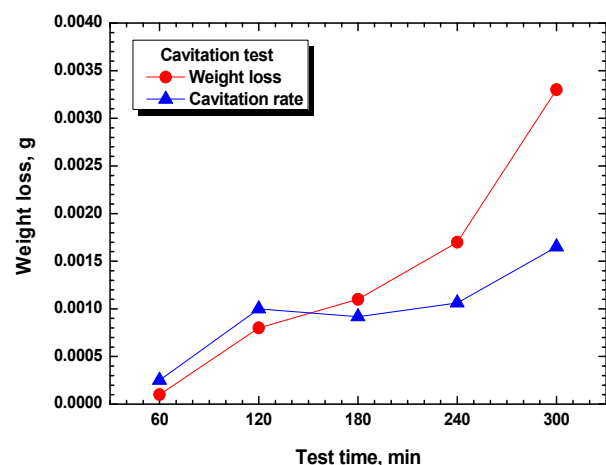
Figure 1: Weight loss and cavitation rate after erosion cavitation test of Al anode with time

Figure 1 shows the weight loss and cavitation rate ($\Delta W(g)/\Delta T(\text{hr})$) of the Al anode relative to the time of an erosion-cavitation experiment. Weight loss (exposed area: 1.98 cm^2) caused by erosion-cavitation were measured and

the results showed a very small value of 0.0001 g until 60 min. of the experimental time, almost linear increase rates until 240 min. and a weight loss of 0.0033 g after 300 min. have elapsed. The cavitation rates increased until 120 min. of the experimental time and decreased a little at the point of 180 min. while showing a tendency of slight increases thereafter until the experiment was finished. After passing the incubation period when pits began to be formed in the surface of the metal due to plastic deformation, as pits grew in the direction of the depth, the cavitation rate increased greatly to 120 min. of the experimental time. At 180 min., pits in the center merged together as soon as grew to show a tendency of slightly decreasing cavitation rates. After 240 min. of the experimental time had elapsed, merged pits grew further and at 300 min. the grown pits merged together to form larger pits, and thereby show a tendency of greatly increasing weight loss and cavitation rate.

Based on the results of the erosion-cavitation experiments, cavitation rate increased greatly until 120 min. of the experimental time and decreased a little at the point of 180 min. where pit grew and merging occurred but showed a tendency of steadily increasing consumption rates. Based on the results of the measurement of potential, cases of flow velocities showed lower potential compared to static states because the thickness of the diffusion layer becomes thinner, and due to this reduction of the diffusion layer, the material shows more active reactions. Based on the results of the anodic polarization experiments, whereas no passivation range occurred in static states, the formation of passive film was active in flow with sufficient oxygen supply and thus passivity was formed. Based on the results of the Tafel analysis, compared to static states, corrosion current densities show a rapidly increasing tendency when flow occurred. This study investigated physical properties and electrochemical characteristics of Al alloy for MGPS due to cavitation and corrosion, respectively. It is common that the presence of cavitation under a corrosive environment induces more damage due to synergistic effect[8] between cavitation erosion and electrochemical corrosion[9]. Therefore, in future work, it is valuable to plan an electrochemical-cavitation

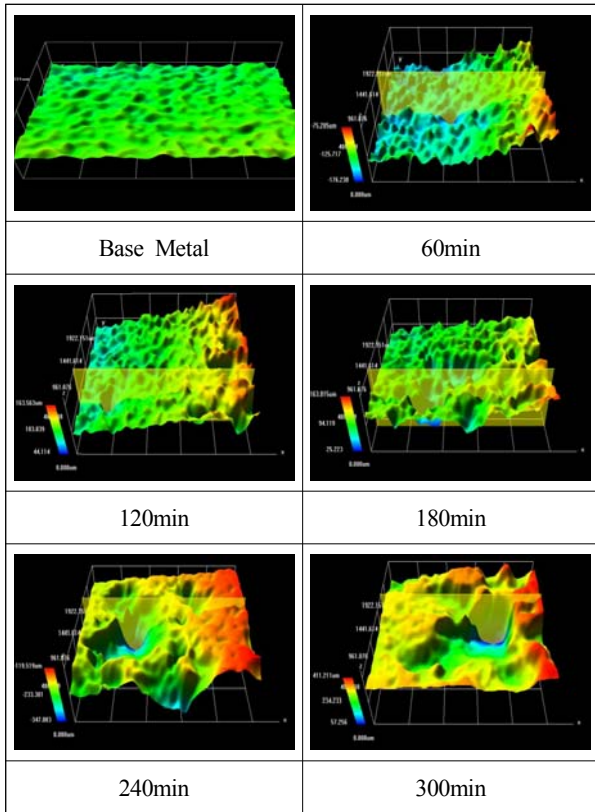
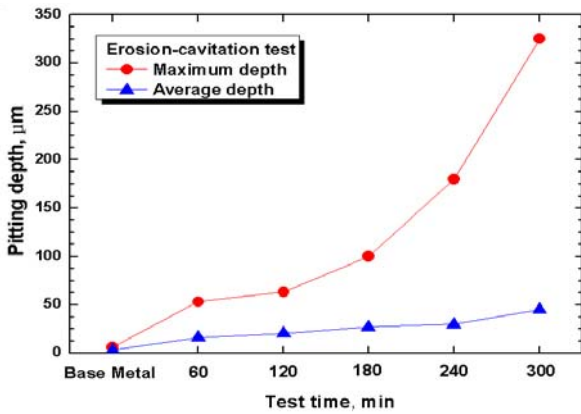
Figure 2: 3D analysis(a) and pitting depth(b) of Al anode after erosion-cavitation test with time

Figure 2 shows an analysis of damaged surfaces of an Al anode and the depths of pitting in the surfaces observed with a 3D microscope after conducting erosion-cavitation experiments for 60 ~ 300 min. The base metal presents a smooth shape with a roughness value of $0.1726 \text{ }\mu\text{m}$. In 60 min. of the experimental time, pits in sizes of maximum $53 \text{ }\mu\text{m}$, average $16 \text{ }\mu\text{m}$ were formed showing rough surface and in 120 min. pits were in a stage of growing in the direction of the depth and pits in sizes of maximum $63 \text{ }\mu\text{m}$, average $20 \text{ }\mu\text{m}$ were formed. At 180 min., pits were in a stage of merging along with growing and pits in sizes of maximum $100 \text{ }\mu\text{m}$, average $27 \text{ }\mu\text{m}$ were formed. At 240 min., large pits occurred on the center and it was judged that erosion appeared on the whole concentrated on the center of the sample to form a large pit in a size of $325 \text{ }\mu\text{m}$ and the

sample and pits in sizes of maximum 80 µm, average 30 µm were shown. In 300 min., pits were surroundings were eroded evenly compared to the central area to show an average depth of 45 µm. The average depth increased constantly over time in general while the maximum depth showed large variations.

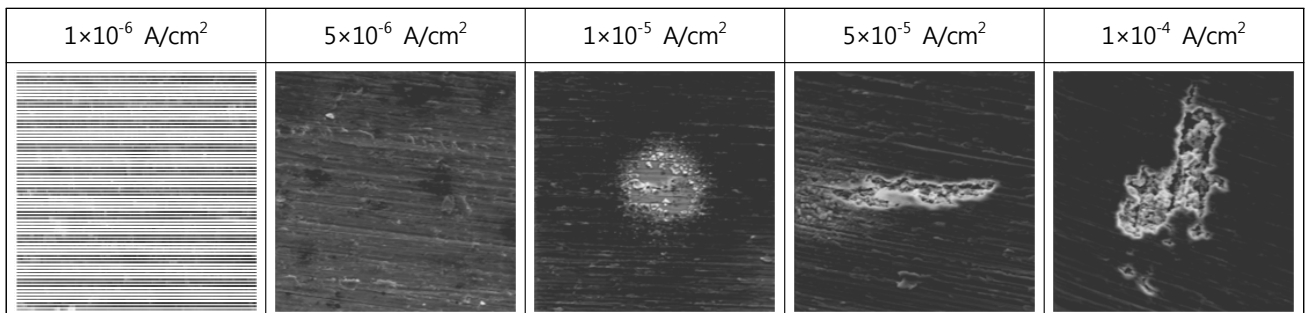
Figure 3: Surface morphologies of Al anode after galvanostatic experiment

Figure 3 presents the surface of Al alloy observed by a SEM after galvanostatic experiment conducted for 3,600 sec. in seawater. At the current densities of 1×10^{-6} A/cm² and 5×10^{-6} A/cm², only very small amounts of dissolution reactions around scratches were observed and generally clean surfaces were shown. At the current density of 1×10^{-5} A/cm², some corrosion caused by dissolution reactions was observed and at the current density of 5×10^{-5} A/cm², the dissolution reactions formed around scratches showed a slightly progressing tendency. At the current density of 1×10^{-4} A/cm², a corrosion tendency toward dissolution reactions formed around scratches mixed with pit corrosion was presented. In general, at low current densities, dissolution reactions began around scratches progressed and as current densities increased, a tendency was shown that the dissolution reaction merged with sporadically occurred pit corrosion sites to damage the surface.

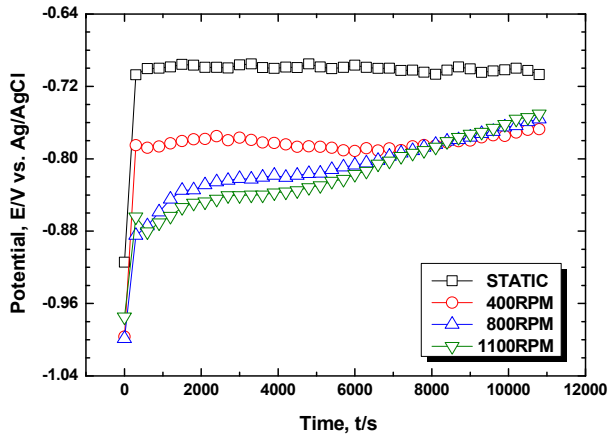
Figure 4: Potential measurement of Al anode with flow velocity

Figure 4 shows the results of potential measurement of an Al alloy relative to changes in flow velocities in seawater. In the case of static states, active potential of -0.914 V was shown at the beginning of immersion and then the potential rapidly moved toward noble direction to show a stable tendency thereafter until the end of the experiment. It is considered that the potential moved to noble direction and then showed a stable value because of the formation of a film such as an Al₂O₃ or Al₂O₃·3H₂O on the surface of Al. In 400 RPM, the potential again rapidly moved toward noble direction at the beginning of immersion to show generally stable potential and then slowly increased after 6,900 sec. to show the potential of -0.767 V at the end of

the experiment. In 800 RPM and 1100 RPM, the potential rapidly moved toward noble direction at the beginning of immersion and then steadily increased thereafter until the end of the experiment. In conclusion, lower potential was shown when there were flow velocities compared to static states and this is because the thickness of the diffusion layer becomes thinner due to flow velocity. Due to this decrease in the diffusion layer, the metal becomes to be subject to more active states and thus it is considered that corrosion damage will be increased compared to static states.

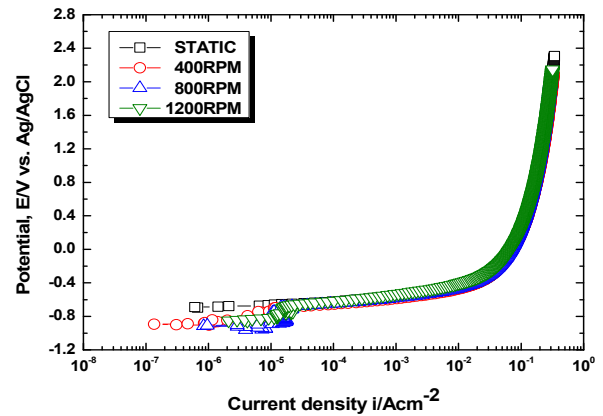
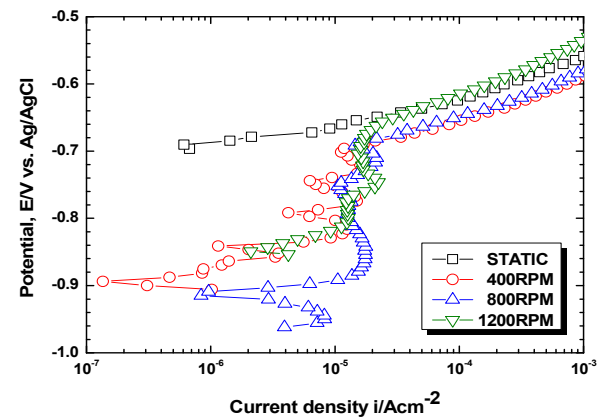
Figure 5: Anodic polarization curves of Al anode with flow velocity

Figure 5 exhibits the tendency of anodic polarization of the Al alloy with flow velocities. No passivation range appeared at static states and as the potential increased, steady increases in current densities were observed. In 5456 Al alloy, during an anodic polarization test, an initial passivity was shown in a range where the potential was slightly higher than the open circuit potential, and then a phenomenon of rapid increases of current densities was shown thereafter due to the occurrence of pitting. Thereafter, the secondary passivity was shown due to the self healing and it could be identified that this was different from the results of previous studies[6]. To compare the passivation ranges relative to flow rates with each other, $-0.857 \text{ V} \sim -0.695 \text{ V}$ was shown in 400 RPM, $-0.885 \text{ V} \sim -0.686 \text{ V}$ was shown in 800 RPM and $-0.805 \text{ V} \sim -0.656 \text{ V}$ was shown in 1100 RPM. A wider range of passivity was shown in 800 RPM compared to the case of 1100 RPM. It is considered that, this is because, although oxygen supply in the solution increased as the speed of revolution increased, the vortex flow created by excessive flow velocities generated air bubbles to reduce the effective area necessary for reactions between the metal and the solution [4][5]. After

the pitting potential, the current density increased along with increases in the potential in almost the same tendencies.

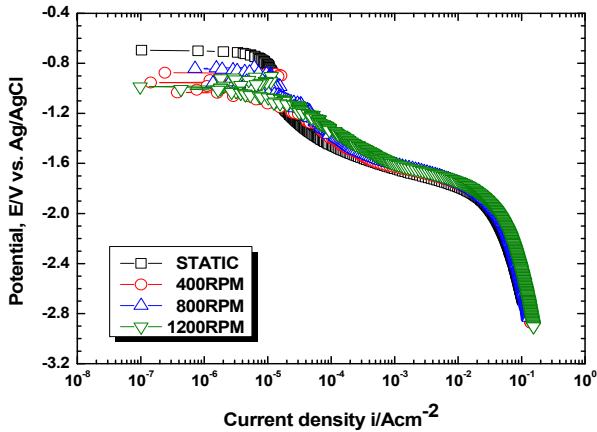
Figure 6: Cathodic polarization curves of Al anode with flow velocity

Figure 6 shows the tendency of the cathodic polarization of the Al alloy with flow velocities in seawater. In static states, as the potential moved from the open circuit potential toward active direction, a tendency of concentration polarization caused by dissolved oxygen reduction reactions and activation polarization caused by the generation of hydrogen gas was clearly observed and generally low current densities were shown due to the effect of the concentration polarization. This concentration polarization range persisted up to around -1.645 V , but when it was placed in a more active potential range, the overall reaction was controlled by activation polarization, resulting in high current densities. This only increased the loss of the anode while little effect on corrosion protection was observed. Therefore, it is suggested that maintaining potential more positive than -1.645 V is necessary under cathodic protection. In cases where flow velocities were applied, concentration polarization did not appear clearly after the open circuit potential due to

the decrease in the thickness of the diffusion layer and the mechanical damage caused by erosion. During the processes, changes in current densities from which the unstable behavior of the concentration interface could be inferred can be observed.

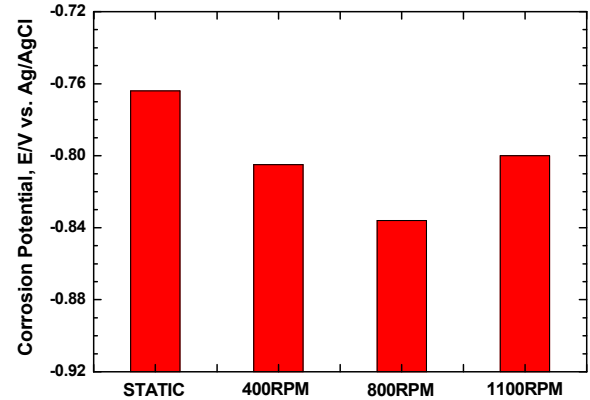
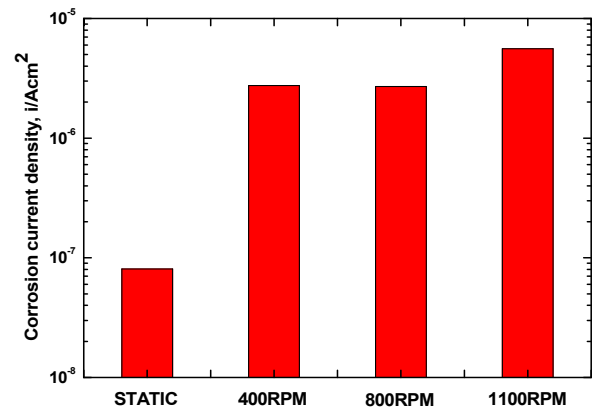
Figure 7: Corrosion potential(a) and corrosion current density(b) of Al anode with flow velocity

Figure 7 presents the results of a Tafel analysis of the Al alloy with flow velocities in seawater. In static states, no passivity was shown as with the anodic polarization curve while all of the cases of 400 RPM, 800 RPM and 1100 RPM showed passivity. As for corrosion potential, static states showed the noblest value of -0.764 V while the case of 800 RPM showed the most active value of -0.836 V though there were no big differences by flow velocities variable. When corrosion current densities were measured by the Tafel extrapolation method, the lowest value of 8.06×10^{-8} A/cm² was shown in static states. The highest corrosion current density of 1.02×10^{-5} A/cm² was shown at 1100 RPM though no big differences were observed by flow velocity variable. Therefore anode dissolution rates are high at 1100 RPM. It is mean that anode consumption rates may be increased to shorten the service life of anodes. In general, when flow rates increase, as the reaction $O_2 + 2H_2O + 4e^- \rightarrow 4OH^-$ increases due to the smooth supply of dissolved oxygen, electron consuming reactions actively occur. In addition, anode oxidation reactions, that is, the reaction $Al \rightarrow Al^{3+} + 3e^-$ also increase and thus corrosion rates increase. However, if flow velocities go over a certain rate, excessive oxygen will be supplied to the surface of the anode and thus an oxidized layer will be formed. That is, $2Al^{3+} + 3O^{2-} \rightarrow Al_2O_3$ will be formed and the corrosion rates will be temporarily decreased in some cases [7]. In conclusion, although a tendency of rapid increases of corrosion current densities compared to static was shown due

to the occurrence of flows, the effect of flow velocity increases was shown to be minor. This is considered to be due to the rotating seawater flow which can reduce the thickness of mass transfer boundary layer and promote the diffusion of Al ions and corrosion products into the solution, resulting in increase of reaction rate.

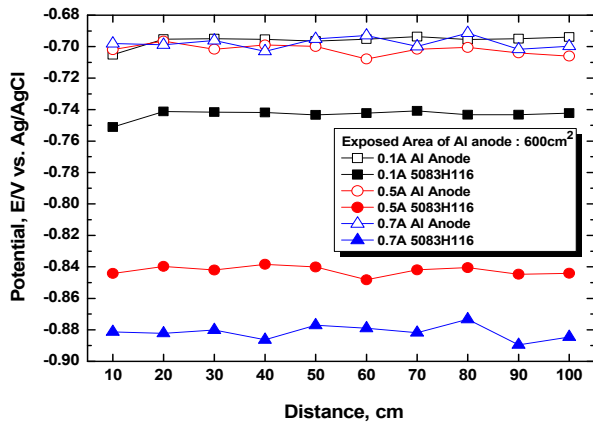
Figure 8: Potential comparison after galvanostatic experiment for 3,600s with distance from Al anode

Figure 8 shows the potential of Al alloy 5083-H116 relative to applied currents and the distance variable when the area of exposure of the Al anode is 600 cm². Since 0.8 A is applied to Al anodes in actual applications, in this study, 0.1 A, 0.5 A and 0.7 A were applied in order to avoid over protection. Regardless of applied currents and distances, the Al anode maintained similar values of -0.707 V ~ -0.691 V. On the other hand, 5083-H116 Al alloy maintained more active potential when applied currents were higher and maintained similar potential in all sections in relation to the effect of distances. The reason is considered to be the fact that since seawater is a very highly conductive solution; no big difference was shown up to 100 cm. Of the three current conditions, 0.1 A corresponds to

the boundary between protection zone and non-protection zone. The 0.5 A ~ 0.7 A corresponds to protection zone as it is a concentration polarization range maintained by dissolved oxygen reduction reactions. Therefore, it is considered that at least 0.5 A of currents should be flowed. Based on Faraday's law, it is considered that the consumption of anodes will be the largest in the case of 0.7 A.
