Comparison of traditional and simplified methods for repairing CAD/CAM feldspathic ceramics

PURPOSE. To evaluate the adhesion to CAD/CAM feldspathic blocks by failure analysis and shear bond strength test (SBSt) of different restorative systems and different surface treatments, for purpose of moderate chipping repair. **MATERIALS AND METHODS.** A self-adhering flowable composite (Vertise Flow, Kerr) containing bi-functional phosphate monomers and a conventional flowable resin composite (Premise Flow, Kerr) applied with and without adhesive system (Optibond Solo Plus, Kerr) were combined with three different surface treatments (Hydrofluoric Acid Etching, Sandblasting, combination of both) for repairing feldspathic ceramics. Two commercial systems for ceramic repairing were tested as controls (Porcelain Repair Kit, Ultradent, and CoJet System, 3M). SBSt was performed and failure mode was evaluated using a digital microscope. A One-Way ANOVA (Tukey test for post hoc) was applied to the SBSt data and the Fisher's Exact Test was applied to the failure analysis data. **RESULTS.** The use of resin systems containing bi-functional phosphate monomers combined with hydrofluoric acid etching

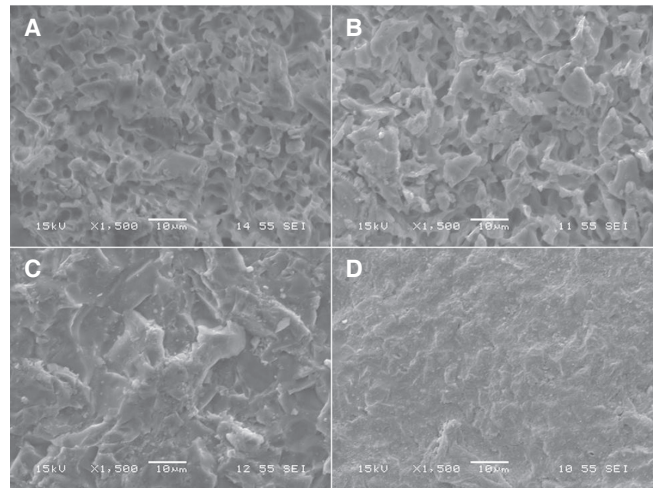
Fig. 1. SEM observation of the ceramic surface treatments. Hydrofluoric acid etching (A), Sandblasting with $100 \mu\text{m}$ Alumina particles followed by hydrofluoric acid etching (B), Sandblasting with $100 \mu\text{m}$ Alumina particles (C) and Tribochemical coating with $30 \mu\text{m}$ Alumina particles coated with silica (D).

The SEM observation of the ceramic surface revealed differences among the tested treatments (Fig. 1). The hydrofluoric acid etching generates regular and deep irregularities on the surface by dissolving the silica amorphous phase of the feldspathic ceramic. When applied after the sandblasting treatment, no morphological difference was observed compared with the ceramic surface treated only by acid etching. The specimens sanblasted with $100 \mu\text{m}$ aluminum particles showed a surface where groves, pits and fissures generated a moderate micromechanical retention for the repairing material. The ceramic surface sandblasted with $30 \mu\text{m}$ alumina particles coated with silica (CoJet Sand) showed the smoothest surface compared with the other ceramic treatments tested.

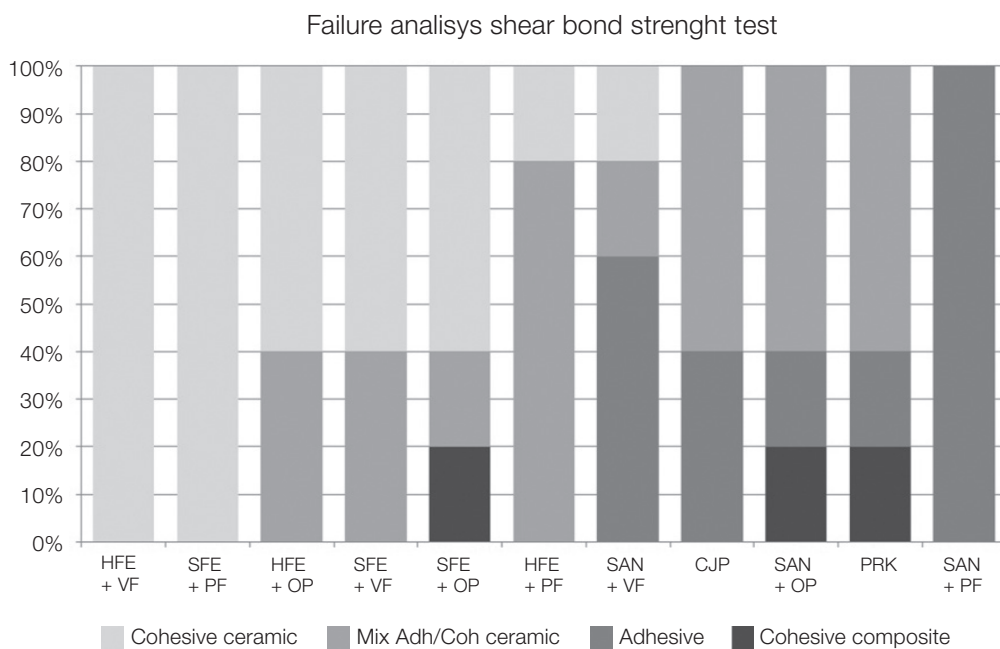
Fig. 2. Failure analysis after shear bond strength test result for groups.

Analysis of failure showed that, for surface treatment, a significantly higher level of favorable fracture mode was shown where the hydrofluoric acid etching was performed compared to sandblasting and tribochemical coating (Table 3). The Vertise Flow showed the best results among the tested materials, with 60% of ceramic cohesive fractures and only 20% of mixed and adhesive fractures, and with no cohesive restorative material fractures. No statistically significant differences were found among Vertise Flow, Premise Flow, and Optibond + Premise Groups (Table 4). Results in percentages for all the groups are summarized in Fig. 2.
