Radiographic study of dermal fillers in the facial area: A series of 3 cases

KEY WORDS: Dermal Fillers; Radiography, Panoramic; Cone-Beam Computed Tomography

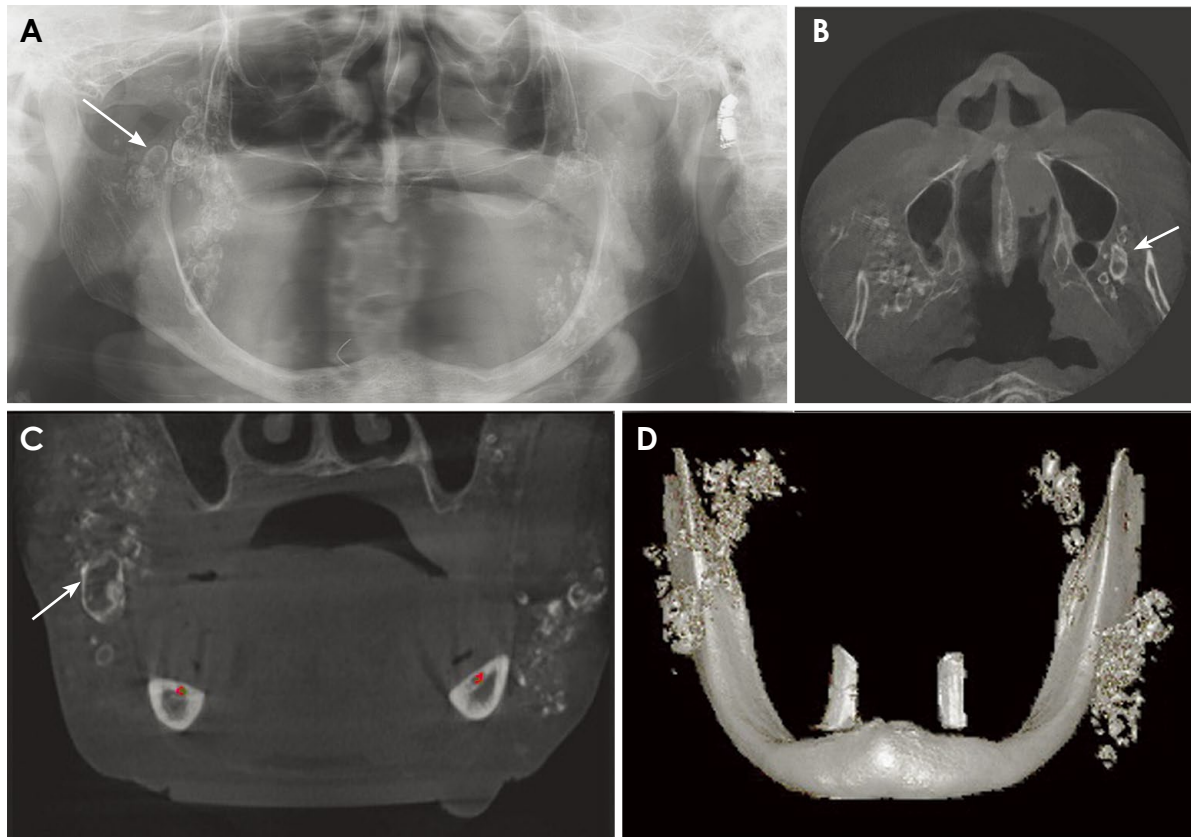
Fig. 1. Panoramic radiograph (A) and axial (B), coronal (C), and 3-dimensional reconstruction (D) of cone-beam computed tomographic images of case 1, demonstrating multiple, amorphous radiopaque masses varying in size in the bilateral cheek areas. Some of the calcifications have a radiolucent center surrounded by a radiopaque rim (arrow). Red dots indicate the mandibular canals.

the patient was treated twice with subdermal injections of filler into both cheeks and zygomatic areas, but the nature of the material used for cosmetic augmentation was unknown. She had no symptoms related to the calcification. CBCT images were acquired with a Pax-Flex 3D apparatus (Vatech, Seoul, Korea), using a 120- \times 85-mm field of view at 90 kVp and 10 mA for implant placement. The CBCT images demonstrated multiple calcifications in the soft tissue of the cheeks and retromaxillary spaces bilaterally (Figs. 1B-D). A few of the opacities were larger than 11 mm in diameter, and were surrounded by a thin radiopaque rim (Fig. 1C, arrow). The calcified lesions were distinct from the adjacent bony structures, and the surrounding soft tissues appeared intact. Based on all available information, the calcifications were concluded to be the consequence of either the long-standing presence of the cosmetic filler itself or as a secondary reaction to the filler.

The patients of case 1 and case 2 underwent soft tissue augmentation twice, so the mineralized particles were observed in a broader area, with various densities and in varying shapes. The difference in density in the image might depend on the composition of the filler¹⁰ or the period elapsed since injection, because the radiodensity of filler decreases with time.¹¹ Case 3 showed filler only in the chin area, highlighting the point that filler can be present at diverse regions in the image, according to the administration site. Therefore, depending on the composition of the filler, the timing of the procedure, and the injection site, filler can be detected at any site with diverse radiopacities and shapes on panoramic and CBCT images.¹²

Current cosmetic fillers are safe,^{7,12} but they can cause short-term and/or long-term side effects.^{12,13} Short-term complications include immediate hypersensitivity reactions, over-injection, necrosis, and change in skin color at the injection site.^{12,13} Long-term adverse effects include delayed hypersensitivity, infection, filler migration, scarring, and foreign-body granuloma formation.^{6,12,13} In addition, the artificially synthesized filler itself promotes a calcification reaction and contributes to the observation of opacities with amorphous or specific shapes on imaging.⁸ Further, foreign-body granulomas are an important cause of secondary calcification, presenting as ring-shaped calcifications, as seen in case 1.⁴

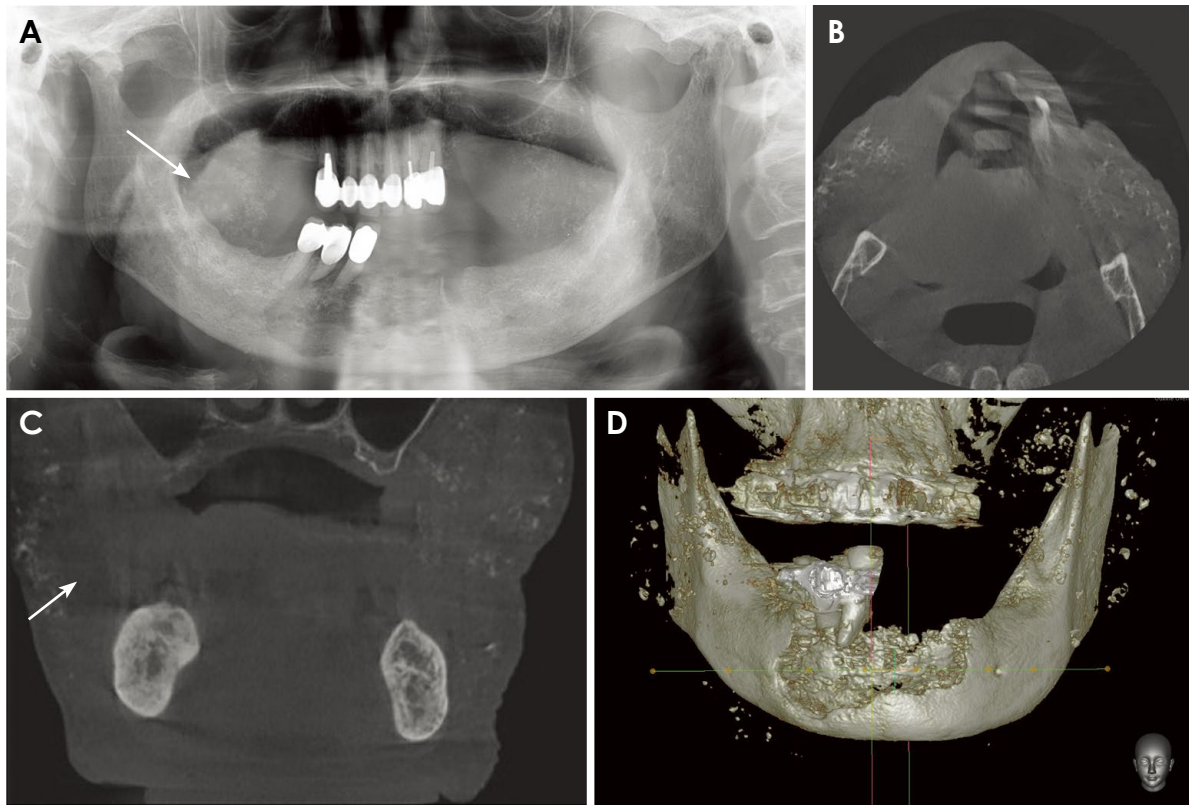
Fig. 2. Panoramic radiograph (A) and axial view (B), coronal view (C), and 3-dimensional reconstruction (D) of cone-beam computed tomographic images of case 2, showing a cluster of small and discrete calcifications on both cheeks and in the right chin area.

the anterior mandible to the Department of Oral and Maxillofacial Surgery, Kyungpook National University Dental Hospital. Her physical examination revealed a purulent discharge with exposed necrotic bone in the anterior mandibular region. A panoramic radiograph taken with an Orthopantomograph OP-100D apparatus revealed ill-defined, osteolytic bony changes with internal radiopacities and surrounding sclerosis in the anterior mandibular area. Apart from this, small multiple radiopacities were observed in both cheeks and on the right side of the chin (Fig. 2A). When questioned, the patient gave a history of injection of some cosmetic material twice into both cheeks approximately 70 years ago. It was an unauthorized procedure and she could not recall the exact type of cosmetic material used. CBCT images were acquired with Pax-Flex 3D using the same parameters as described above, and showed multiple large calcifications in the soft tissue of retromaxillary space, both cheeks, and the right chin area (Figs. 2B-D). The calcifications were separate from the adjacent bony structures, and the surrounding soft tissues appeared normal. The multiple radiopacities were diag-

nosed as filler-induced radiopacities based on the imaging findings and history; the patient subsequently underwent surgical treatment for the anterior mandibular osteomyelitic lesion.

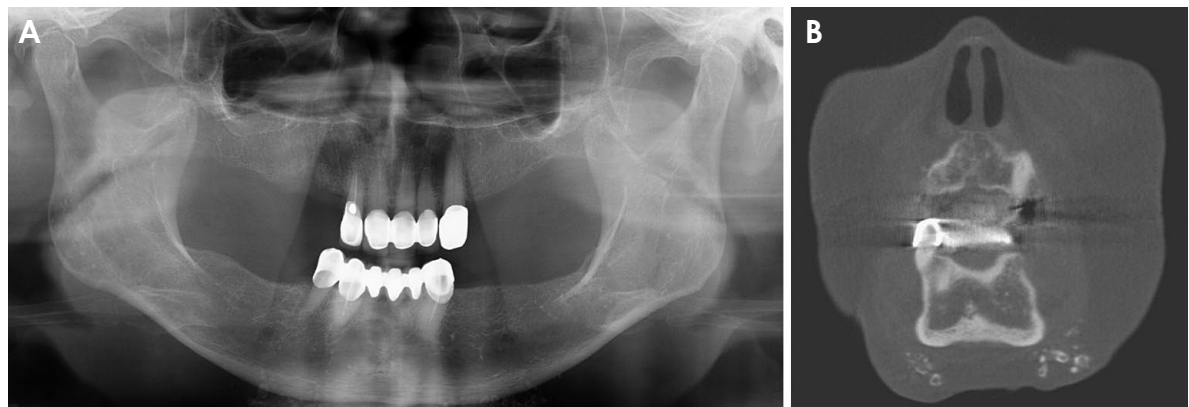
Fig. 3. Panoramic radiograph (A) and coronal (B) cone-beam computed tomographic images of case 3, showing small ring- and nodule-shaped calcifications in both chin areas.

therapy for the last 5 years. A panoramic radiograph revealed recent extraction sockets in the right maxillary premolar area (Fig. 3A). In the chin area, a cluster of small multiple radiopacities was noted in the soft tissue. Upon enquiry, the patient gave a history of subdermal filler injection into the chin area at an unlicensed center approximately 40 years ago. CBCT images acquired with a CB MercuRay apparatus (Hitachi Medical Systems, Tokyo, Japan), using a 190- × 190-mm field of view at 120 kVp and 15 mA demonstrated multiple nodular or ring-shaped radiopacities in the soft tissue of the chin area (Fig. 3B). The masses were distinct from the adjacent bony structures, and the surrounding soft tissue appeared healthy. Considering her history and the clinical and radiographic information, it was concluded that the symmetrical calcification was due to the implantation of a cosmetic filler.
