Correlation analysis between radiation exposure and the image quality of cone-beam computed tomography in the dental clinical environment

Purpose: This study was conducted to measure the radiation exposure and image quality of various cone-beam computed tomography (CBCT) machines under common clinical conditions and to analyze the correlation between them.

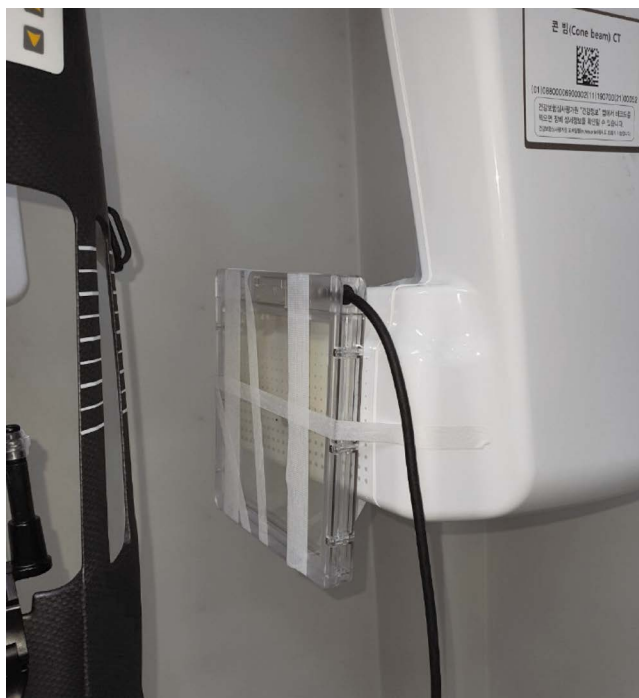
Fig. 1. A flat plane ionization chamber of a dose-area product meter is attached to the source side of the cone-beam computed tomography device.

The radiation exposure for each CBCT machine was measured using a DAP meter, KermaX plus (IBA Dosimetry, Schwarzenbruck, Germany) (Fig. 1). The DAP meter was calibrated at the manufacturer's headquarters in Germany within 3 months of the experiment, and the calibration value presented in the report was used as a calibration factor. The DAP values were measured 3 times under the same conditions, and the average was recorded to minimize the error.

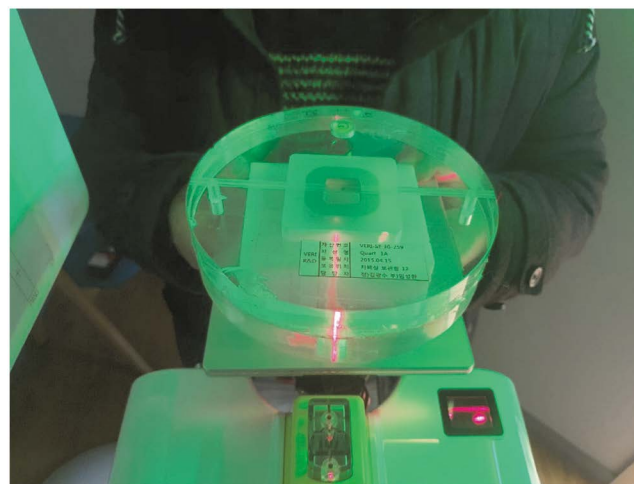
Fig. 2. A dental volume tomography phantom is positioned using a fabricated mounting table with a flat top. The center of the phantom is positioned at the center of the field of view of the cone-beam computed tomography device.

The quality of the CBCT images was evaluated using a DVT phantom (Quart GmbH, Zorneding, Germany). The DVT phantom was mounted using a fabricated mounting table with a flat top and positioned using a 3-axis horizontal system (Fig. 2). The acquired images were analyzed using DVT TEC software (Quart GmbH, Zorneding, Germany). Eight image quality values were obtained and analyzed:
