Evaluation of the effects of the river restoration in Hwangji Stream, the upstream reach of the Nakdong River

Keywords: adaptive management, evaluation, Hwangji Stream, restoration effect, river restoration

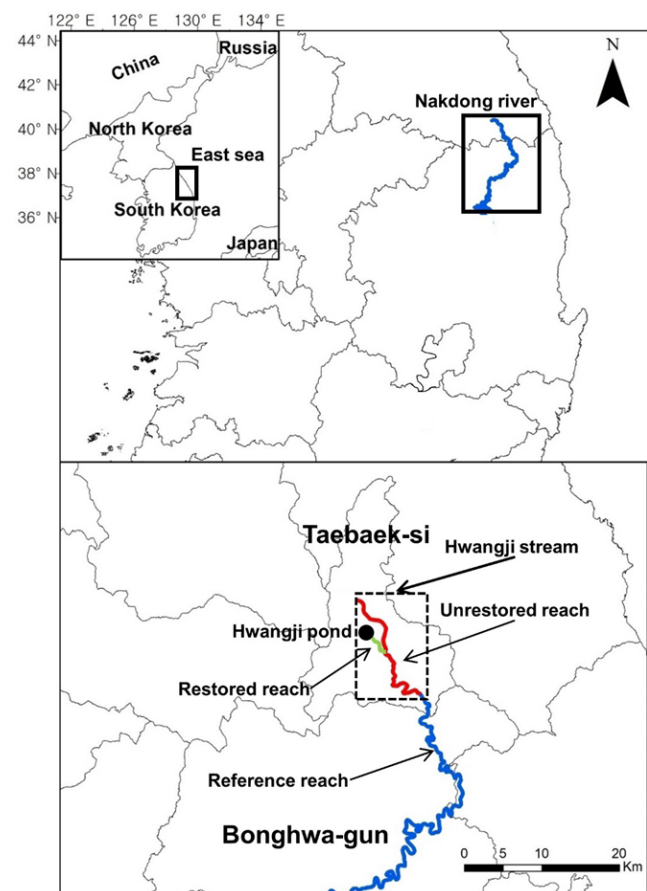
Fig. 1 A map showing the study areas. The restored reach is a tributary, which starts from the Hwangji Pond and joins into the Hwangji Stream. The reference river was selected in the upstream reach of the Nakdong River (blue colored reach), which runs from Taebaek, Gangwon-do to Bonghwa, Gyeongsangbuk-do. In addition, the Taebaek City reach of the Hwangji Stream (red colored reach), as an unrestored urban river, was selected for comparing with the restored stream.

The Nakdong River originates from the Neodeol spring of Mt. Cheoneui in Taebaek City and enters the South Sea via the mouth of the Nakdong River in Saha-gu, Busan. However, the origin of the Nakdong River is known to the public as Hwangji Pond, located in Hwangji-dong, Taebaek City. This study was carried out in a tributary section of Hwangji Stream, which starts from Hwangji Pond and joins Hwangji Stream. The reach had been covered for a long time, but was restored through a river restoration project, which is supported by the central government, the Ministry of Environment and practiced by the local governments (Fig. 1).

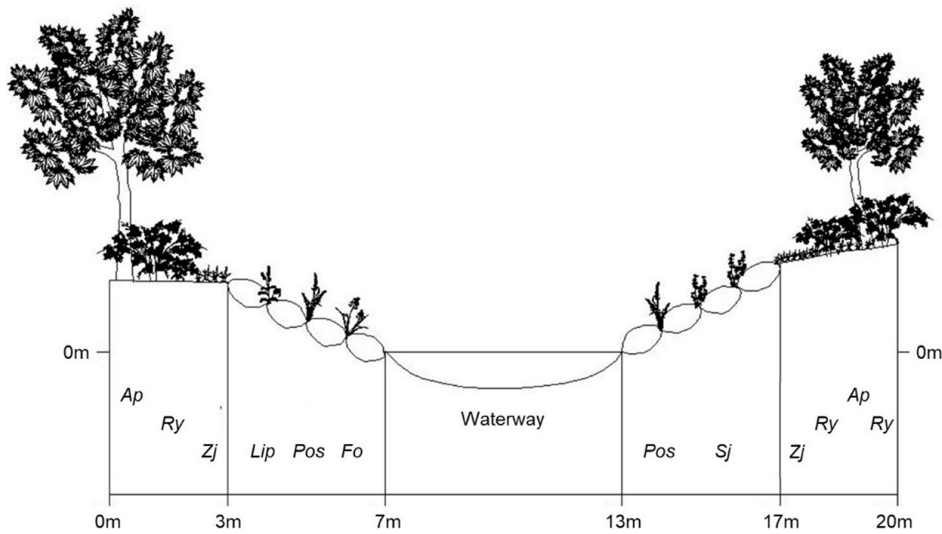
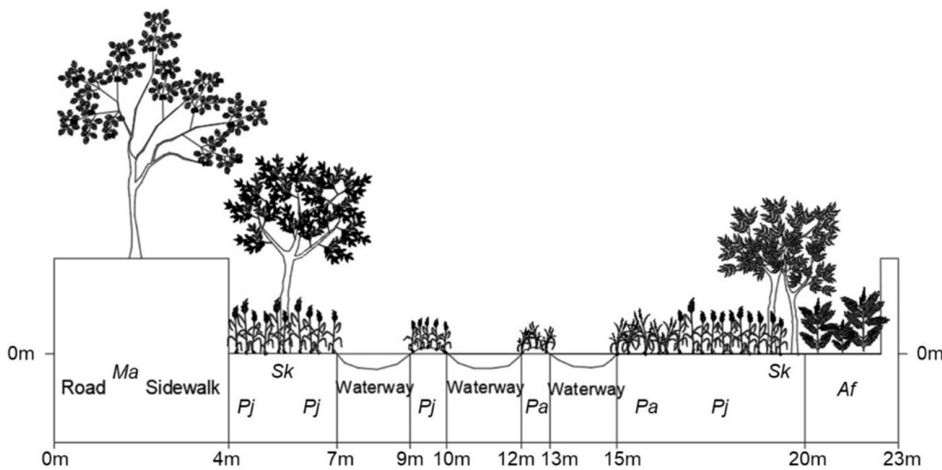
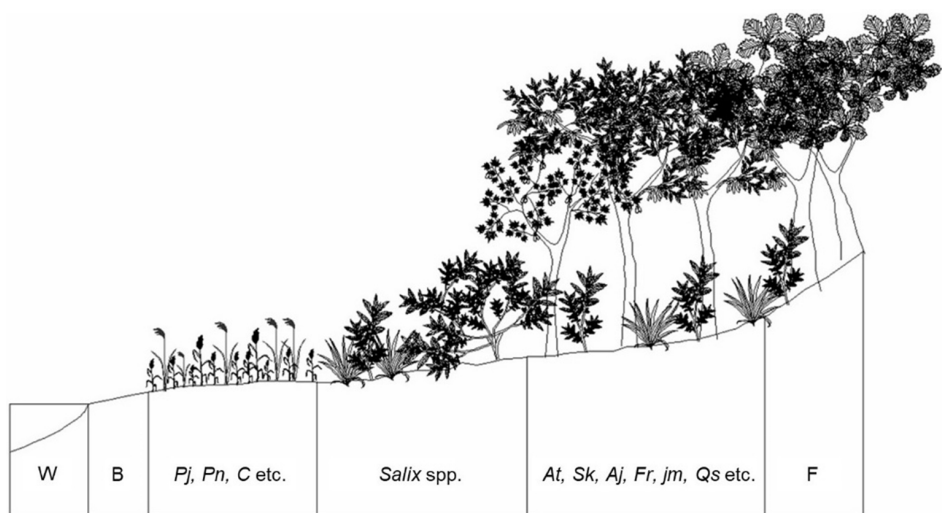
A) Restored reach

B) Unrestored reach

C) Reference reach

Fig. 2 A comparison of the representative stand profiles of riparian vegetation in the restored, unrestored, and reference natural reaches of the Nakdong River. Ap: *Acer palmatum*; Ry: *Rhododendron yedoense* for. *Poukhanense*; Zj: *Zoysia japonica*; Lip: *Liriope platyphylla*; Pos: *Poa sphondylodes*; Fo: *Festuca ovina*; Sj: *Stachys japonica*; Ma: *Morus alba*; Pj: *Phragmites japonica*; Sk: *Salix koreensis*; Pa: *Phalaris arundinacea*; Af: *Amorphosa fruticosa*; W: waterway; B: bare ground; Pn: *Persicaria nodosa*; C: *Carex* spp.; At: *Acer tataricum* subsp. *Ginnala*; Aj: *Alnus japonica*; Fr: *Fraxinus rhynchophylla*; jm: *Juglans mandshurica*; Qs: *Quercus serrata*; F: upland forest.

The spatial extent of the restored Hwangji Stream tributary is defined by stacking stones instead of concrete walls (Fig. S4). Compared to the concrete walls, it is also possible to observe positive aspects such as gentle slopes and small gaps in these river sections, but still focusing on civil engineering rather than ecological restoration. The introduced vegetation is not only far from river vegetation, but also exotic species are introduced, which are also far from ecological restoration. The embankment was constructed by stacking stones from the bottom to the top, and *Lolium perenne*, *Sedum kamtschaticum*, *Thymus quinquecostatus*, *Hosta longipes*, and *Dianthus deltooides* were planted. *Pinus densiflora*, *Chionanthus retusus*, *Zelkova serrata*, etc., were planted like street trees next to the sidewalk on the top of the embankment. Except for *H. longipes* and *Z. serrata*, species that did not match the riparian zone were introduced (Fig. 2 and Fig. S4).

The Taebaek City reach of the Hwangji Stream, which was not treated as a restoration project, is a typical urban stream in Korea, and the spatial range of the river is limited by concrete walls (Fig. S3). However, vegetation established in the waterway reflect the natural disturbance regime caused by the flow of water. The spatial distribution of vegetation reflects the frequency and intensity of floods, and thus grasslands dominated by *Phalaris arundinacea* and *P. japonica* were established near the waterway, and as the distance from the waterway becomes farther away, shrubby willow including *Salix integra* dominating vegetation and *Salix koreensis* dominating vegetation appeared continuously (Fig. 2).

Stand profiles of riparian vegetation collected from seven upstream reaches of the Nakdong River, where the riparian vegetation is well conserved, are shown in Figure 2. Riparian vegetation appeared in the order of grassland, shrubland, and tree forest, as far away the distance from the waterway, and thus tended to reflect the flooding disturbance regime. The *P. japonica* community and mixed community of *P. japonica* and *Salix gracilistyla* dominated the grassland zone. The shrub zone was dominated by *S. gracilistyla*.

The reference information systematized by synthesizing the above-mentioned results was expressed as a stand profile including waterway, bare ground, grassland, shrub, tree forest, and upland forest zones (Fig. 2). We recommended *P.*
